# 2014 Baker Quarters Fire

10/2/2014

# Baker Platform Summary

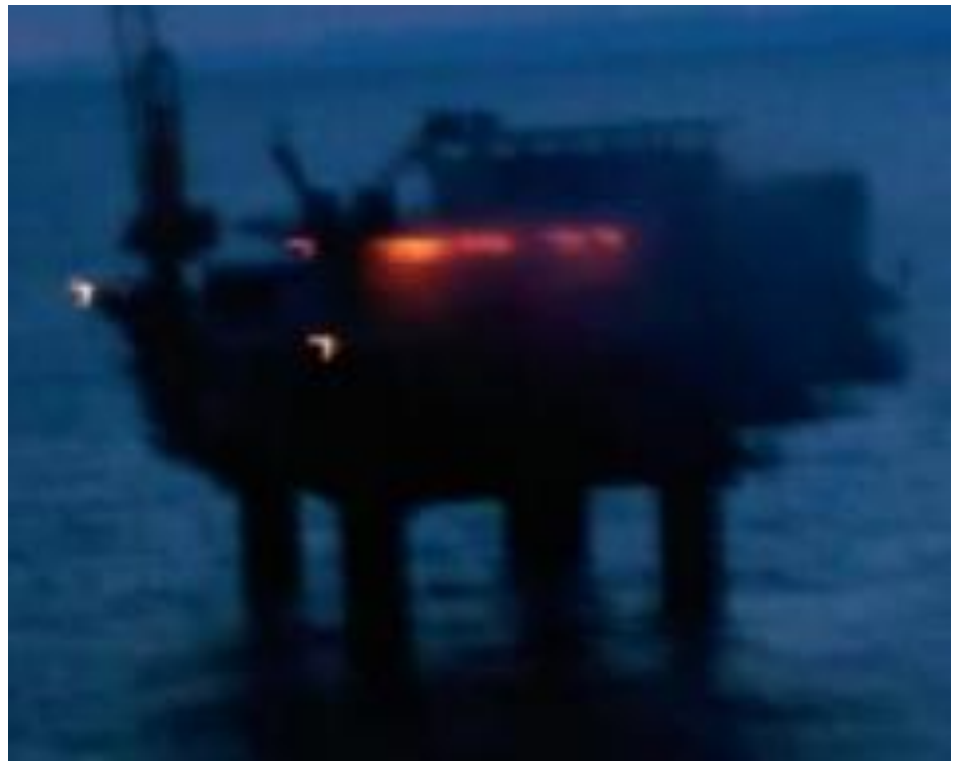
# Initial Fire Photo

- Taken at 7:44 am
- Taken right before crew evacuation

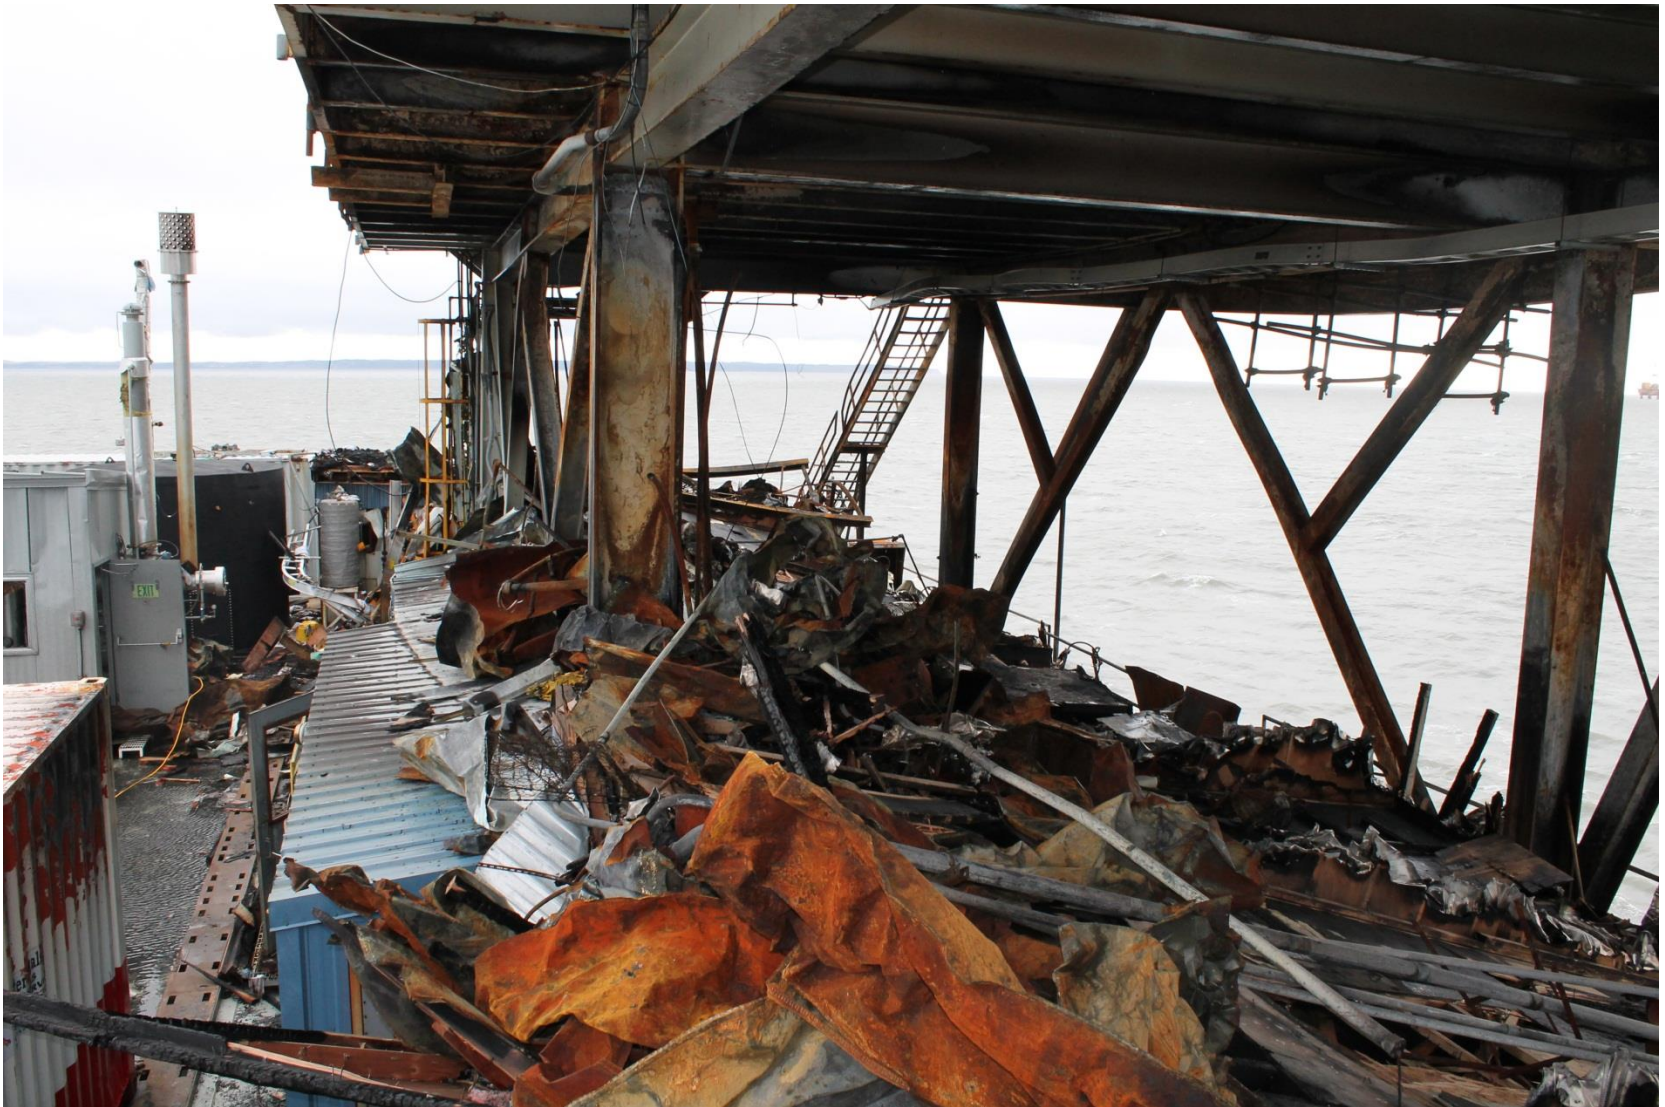
# Lower Quarters

Lower Quarters: Total Loss

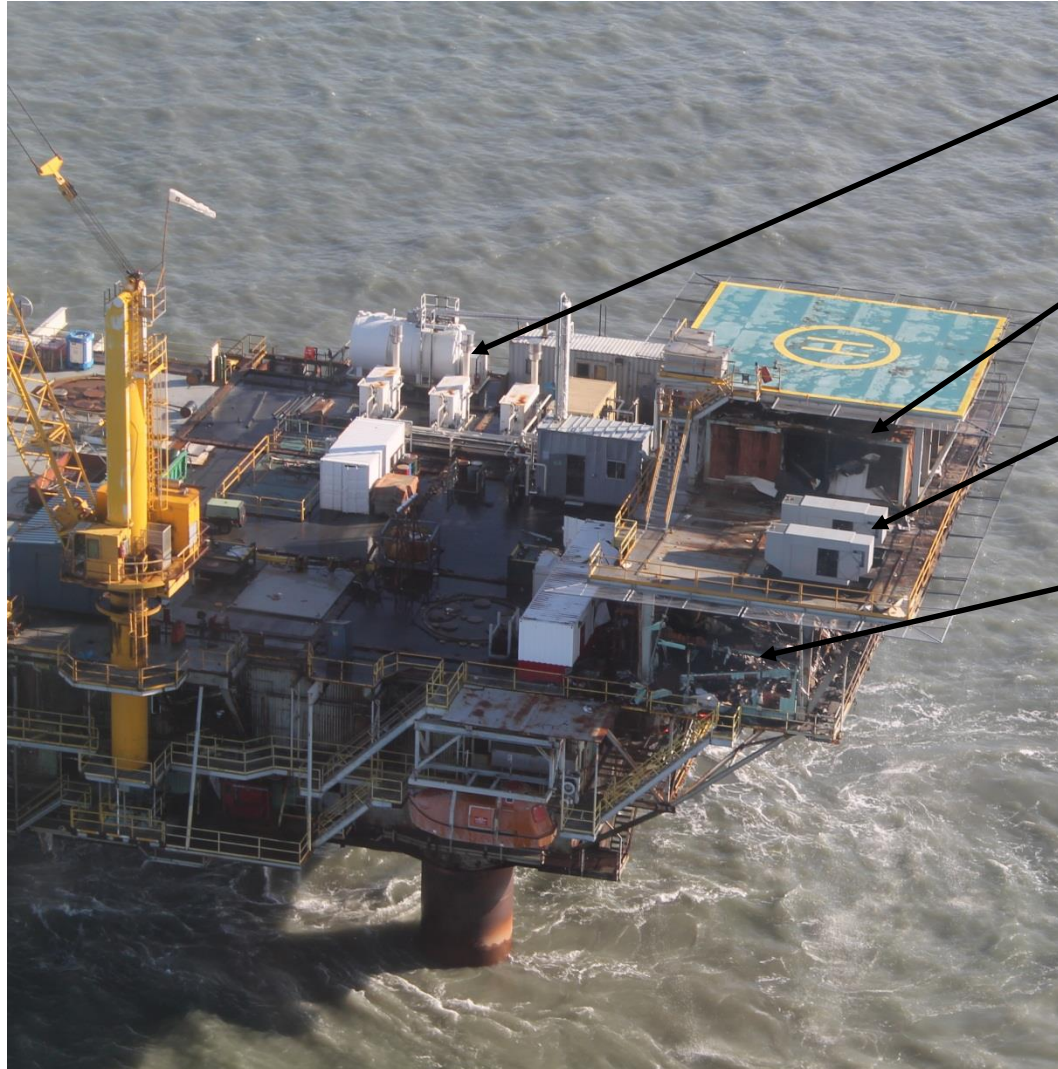
# Post Fire View

Process Equipment: Minor damage due to debris and water cannons

Drilling Quarters : Total Loss

SRC Generator: Damaged by water cannons

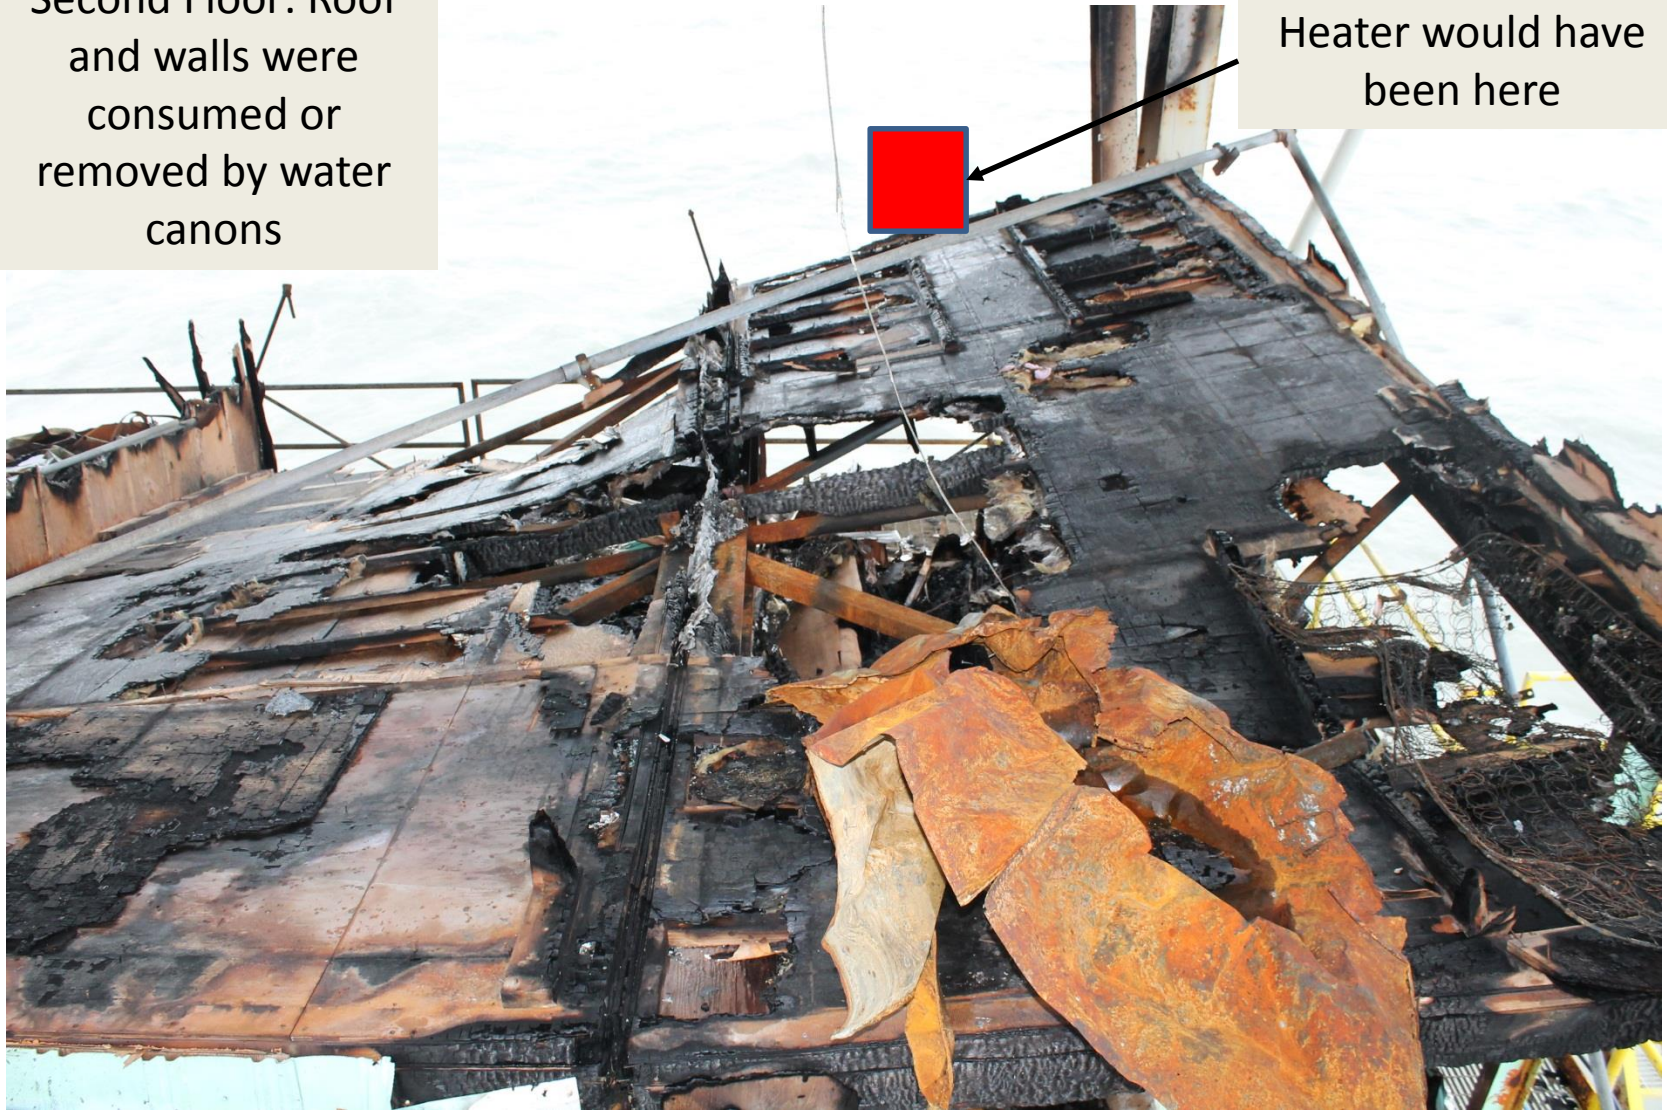
# South West Bedroom

Second Floor: Roof  
and walls were  
consumed or  
removed by water  
canons

Heater would have  
been here

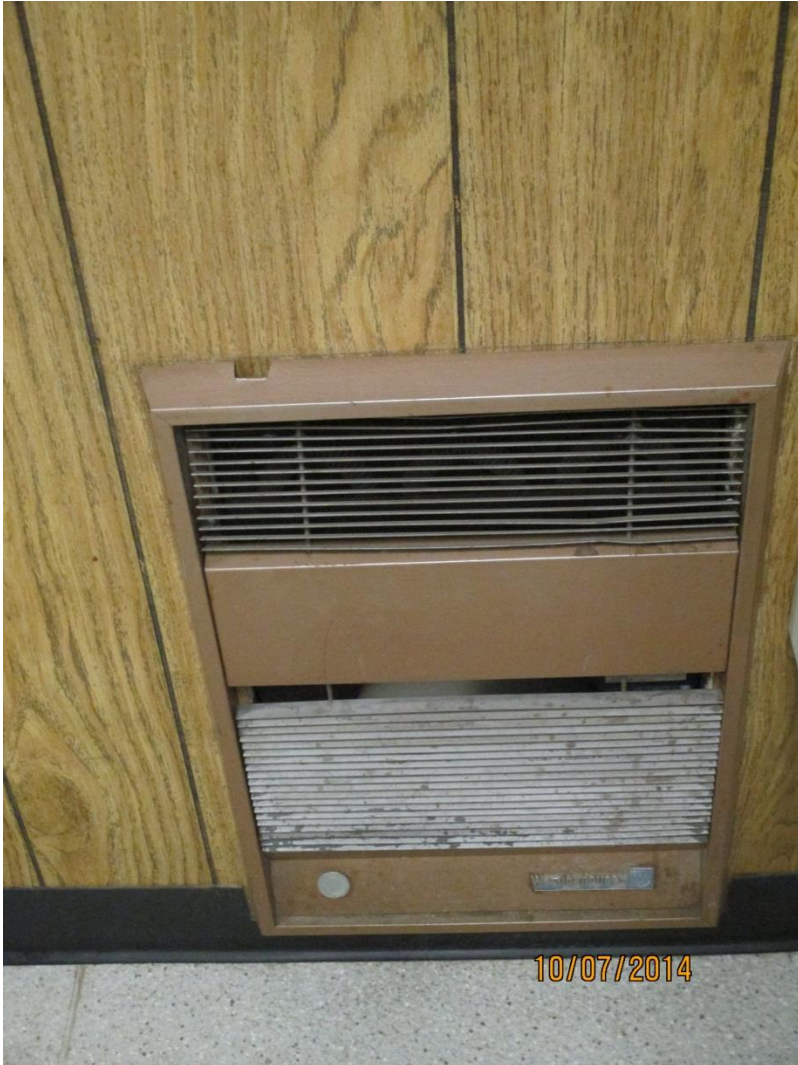
# 1200 Watt Wall Heater

- 1200 Watt heater was original from 1960's installation
- Annual Maintenance was performed by Electrician on 9/28/14
- Quarters were old ATCO modular 2X4 housing construction with wood paneling

(Similar heater on Anna)

- Wall Heater electrical components or associated wiring inside the wall
  - Supporting Evidence from eye witnesses:
    - Started in Upper West Bed Room
    - White/Grey Smoke - smelled electrical
    - No glow or fire was visible in room
  - Upper West Bed Room
    - No one was assigned to the room that week
    - 1200 Watt Electric Wall Heater on South outside wall
    - No other known electrical loads in that wall
    - No new construction in last 10 years in this area
  - Post Fire Evidence
    - None: South West Bed Room walls and roof did not survive fire

- On all other platforms, check electrical components associated with the wall heaters and wall spaces of quarters with similar installations.
- Checks will include verification of electrical components; heater and associated wiring inside the wall by 10/20/14
