Hilcorp Alaska, LLC

Cook Inlet Offshore Update

MGS A to Shore Pipeline

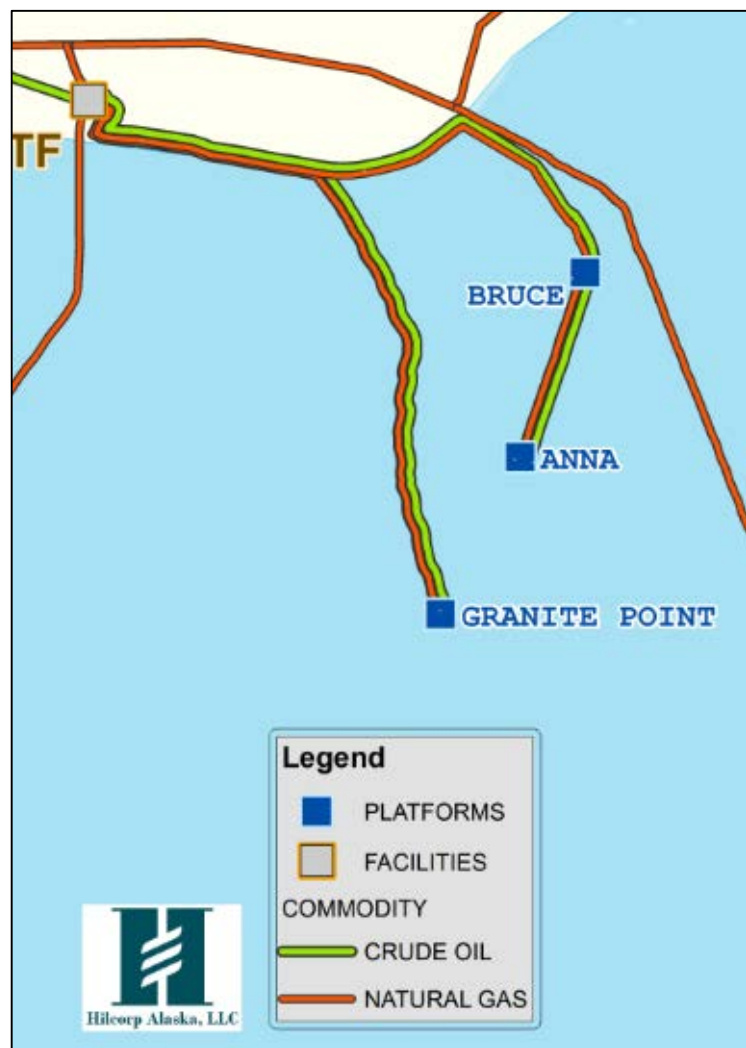
Anna Spill Summary

- Spill Estimated Volume < 3 Gallons
- Immediately shutdown oil shipping pumps and notified Hilcorp EH&S
- Flushed 495 bbl of oil from Anna to Bruce with seawater to eliminate spill potential
- Performed operational hydro test of pipeline at 340 PSI and had no leak
- Still investigating leak source

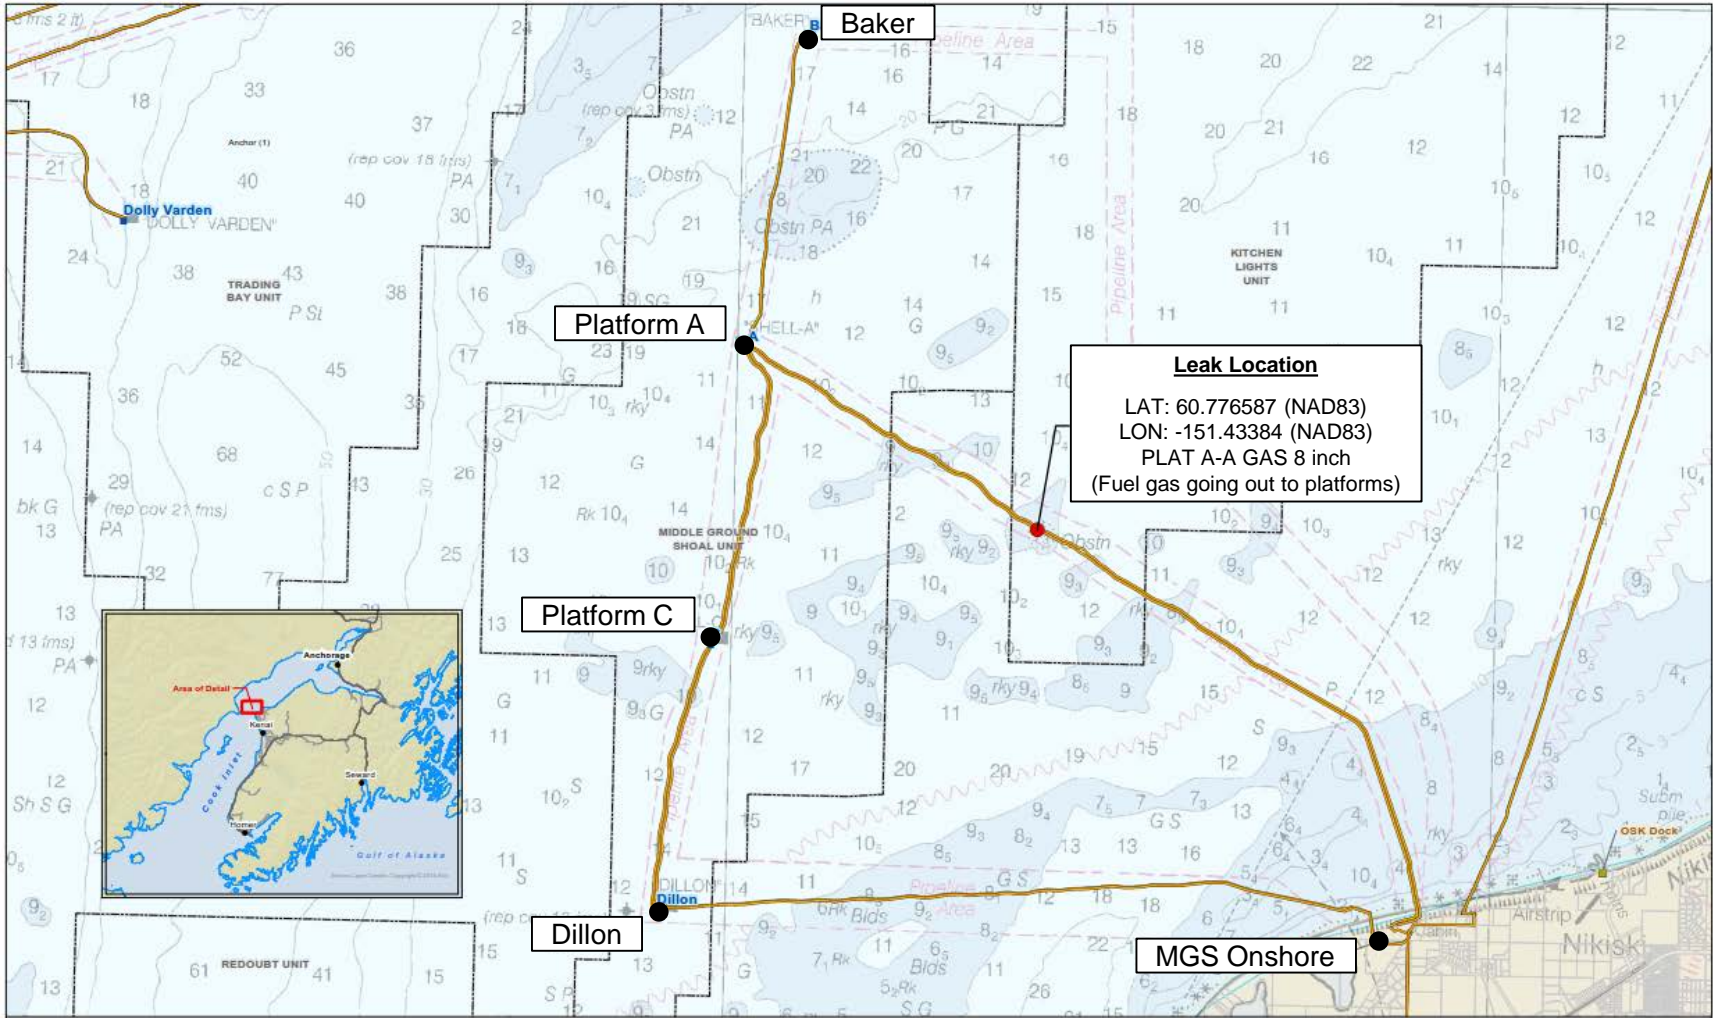
- Pipeline was installed in 1965.
- Pipeline converted from oil to gas service in 2005.
- Residual oil exists in the line at an unknown volume.
- Gathered data in 2016 on pipelines after purchasing assets in late 2015. (thickness readings, spans, etc.)
- Leak location is on rock outcrop.

- **February 7th, 2017:**
 - Leak confirmed
 - Normal operating pressure ~200psi
 - Flowrate ~2.34 MMscfd
 - Leak rate estimated between 210-310 Mcfd
- **February 15th, 2017:**
 - Shutdown water flood processes on platforms
 - Reduced pipeline pressure to ~160 psi
 - Reduced flowrate to ~1.94 MMscfd
- **March 14th, 2017:**
 - Reduced pipeline pressure to ~150 psi
 - Reduced flowrate to ~1.87 MMscfd
- **March 25th, 2017:**
 - Shutdown oil/gas processes on platforms
 - Reduced pipeline pressure to ~65 psi
 - Reduced flowrate to ~0.55 MMscfd
 - Reduced estimated leak rate to 85 – 115 Mcf/day

- Dive crews are ready to mobilize as soon as conditions permit.
- Temporary clamp installation (3-5 days).
- Permanent clamp installation (5-7 days).
