Hilcorp Alaska, LLC

**Cook Inlet
Offshore
Update**

MGSA to Shore Pipeline

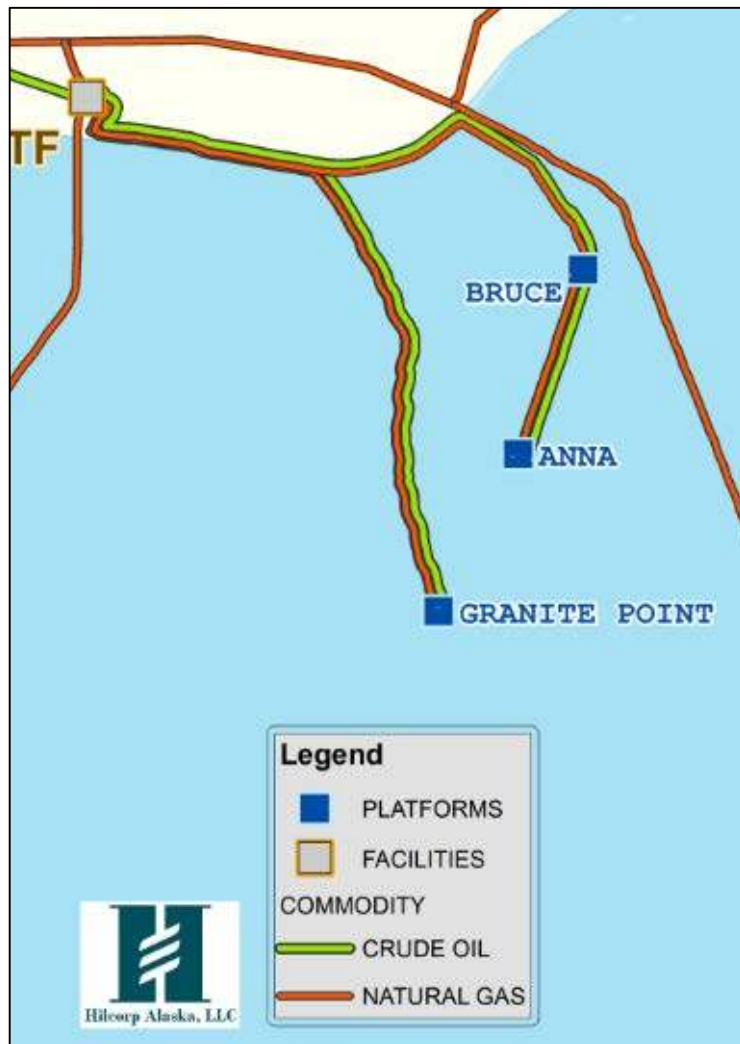
Anna Spill Summary

- Spill Estimated Volume < 3 Gallons
- Immediately shutdown oil shipping pumps and notified Hilcorp EH&S
- Flushed 495 bbl of oil from Anna to Bruce with seawater to eliminate spill potential
- Performed operational hydro test of pipeline at 340 PSI and had no leak
- Still investigating leak source

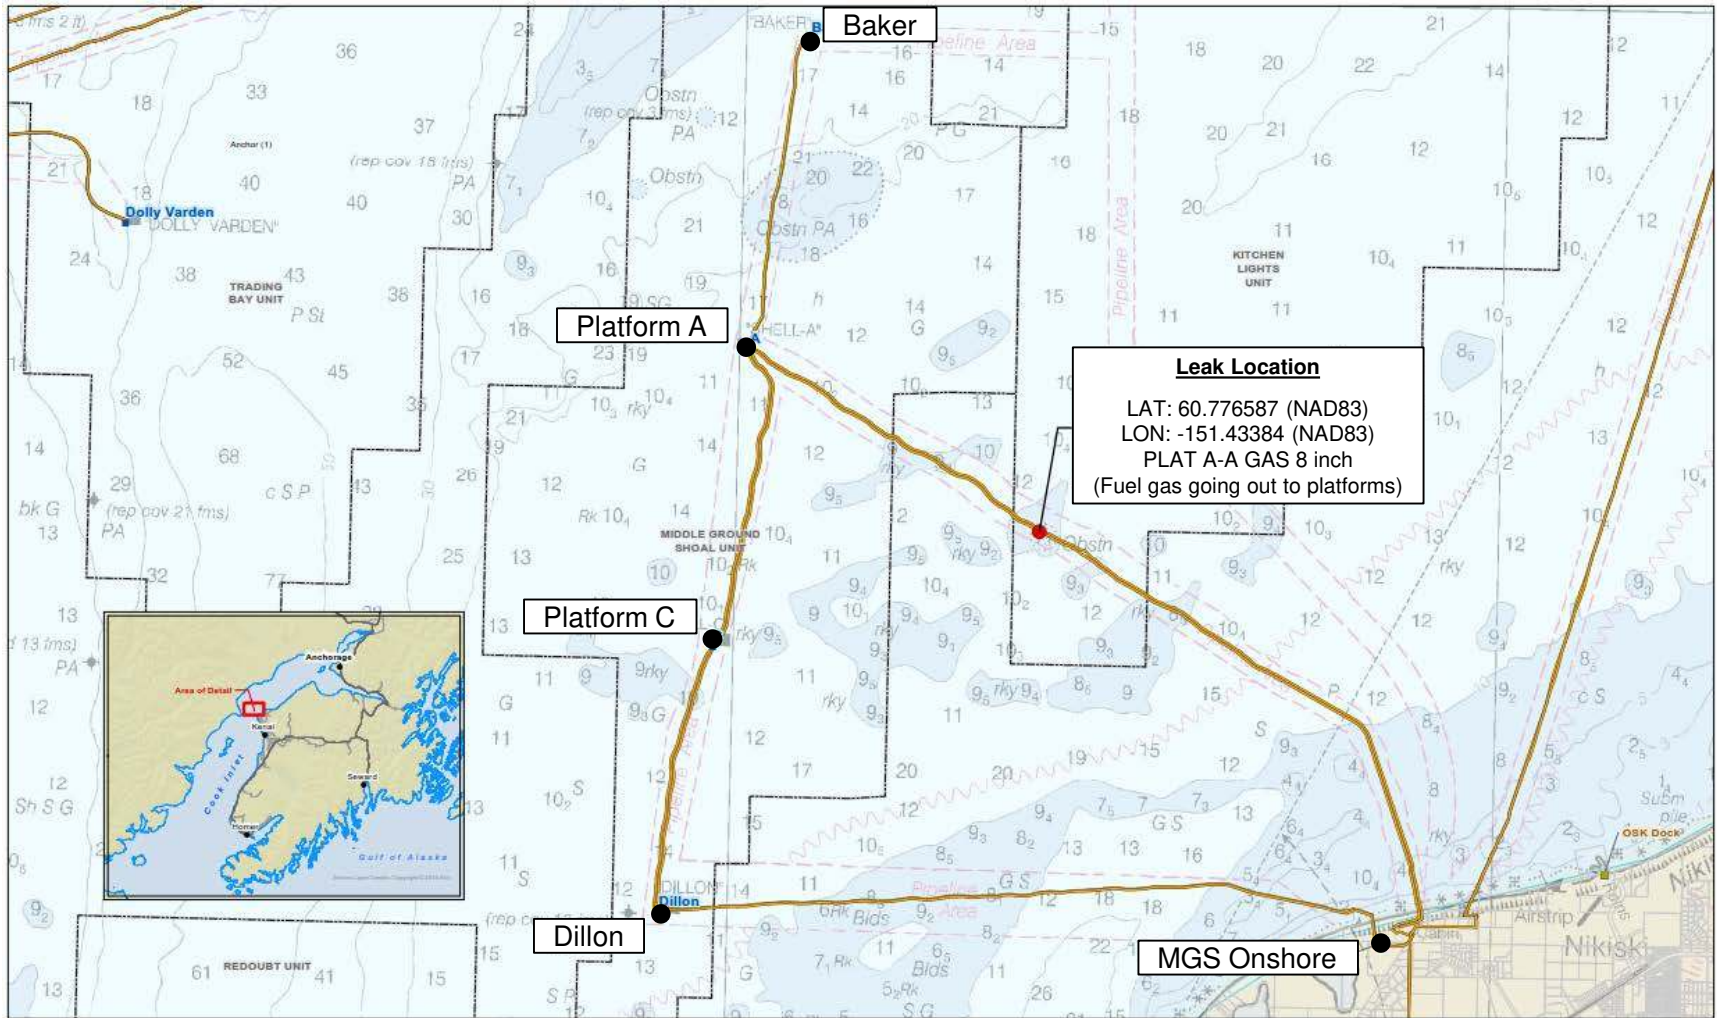
MGSA to Shore Pipeline

- Pipeline was installed in 1965.
- Pipeline converted from oil to gas service in 2005.
- Residual oil exists in the line at an unknown volume.
- Gathered data in 2016 on pipelines after purchasing assets in late 2015. (thickness readings, spans, etc.)
- Leak location is on rock outcrop.

- **February 7th, 2017:**
 - Leak confirmed
 - Normal operating pressure ~200psi
 - Flowrate ~2.34 MMscfd
 - Leak rate estimated between 210-310 Mcfd
- **February 15th, 2017:**
 - Shutdown water flood processes on platforms
 - Reduced pipeline pressure to ~160 psi
 - Reduced flowrate to ~1.94 MMscfd
- **March 14th, 2017:**
 - Reduced pipeline pressure to ~150 psi
 - Reduced flowrate to ~1.87 MMscfd
- **March 25th, 2017:**
 - Shutdown oil/gas processes on platforms
 - Reduced pipeline pressure to ~65 psi
 - Reduced flowrate to ~0.55 MMscfd
 - Reduced estimated leak rate to 85 – 115 Mcf/day

- Dive crews are ready to mobilize as soon as conditions permit.
- Temporary clamp installation (3-5 days).
- Permanent clamp installation (5-7 days).
