Kulluk Grounding

Captain Paul Mehler III

Commander, United States Coast Guard Sector Anchorage

**REPORT OF INVESTIGATION INTO THE CIRCUMSTANCES SURROUNDING THE
GROUNDING OF THE MOBILE OFFSHORE DRILLING UNIT (MODU) KULLUK ON
THE EASTERN COAST OF SITKALIDAK ISLAND, ALASKA
ON DECEMBER 31, 2012**

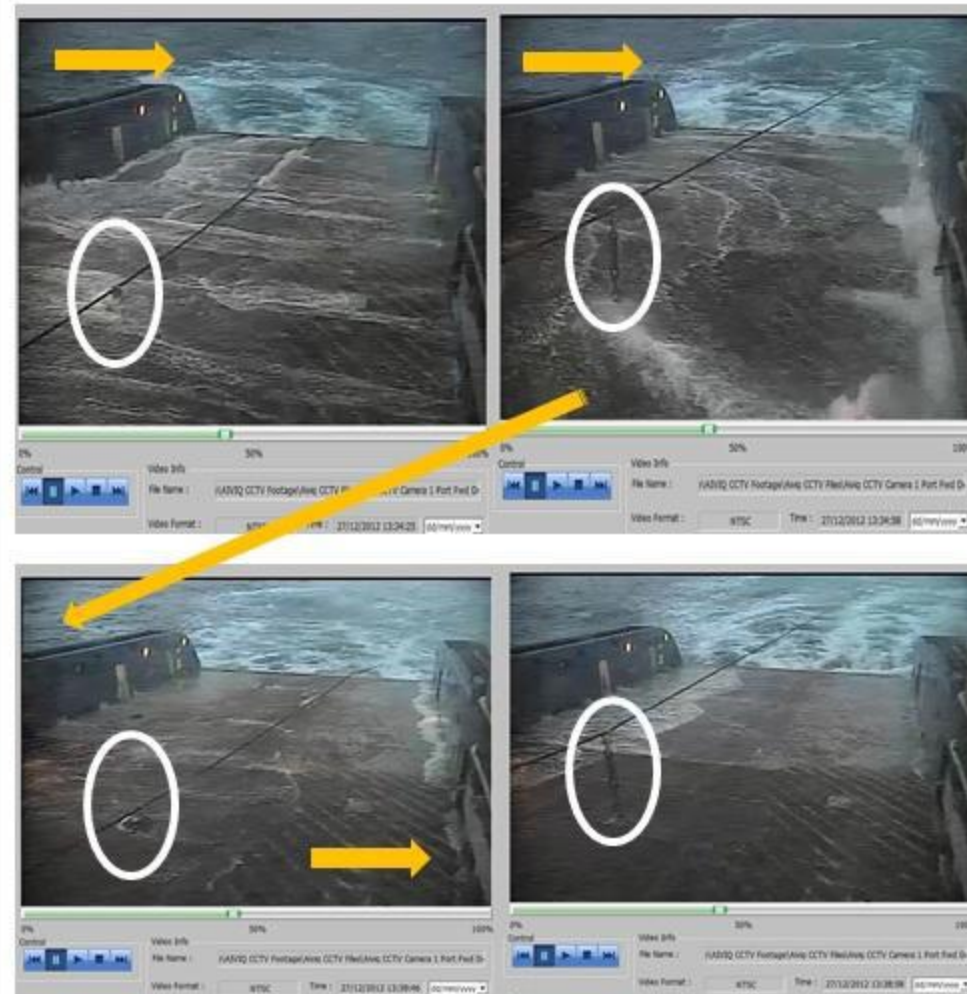
Sequential video captures from the CCTV taken aboard the AIVIQ with the starboard aft CCTV camera showing the fluctuations in the tension on the "Deadman" or "Hogging Chain" which is highlighted by a white oval shape. These captures were taken from AIVIQ CCTV footage after daylight on December 27, 2012. (CCTV Provided by ECO with USCG analysis)

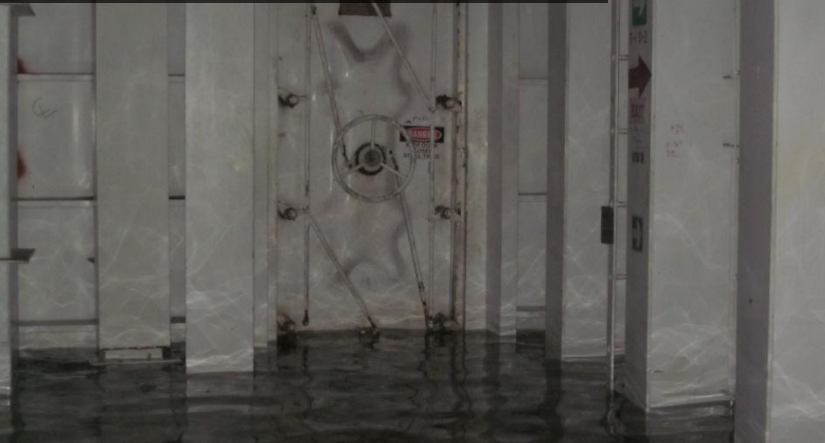
Flooded compartment

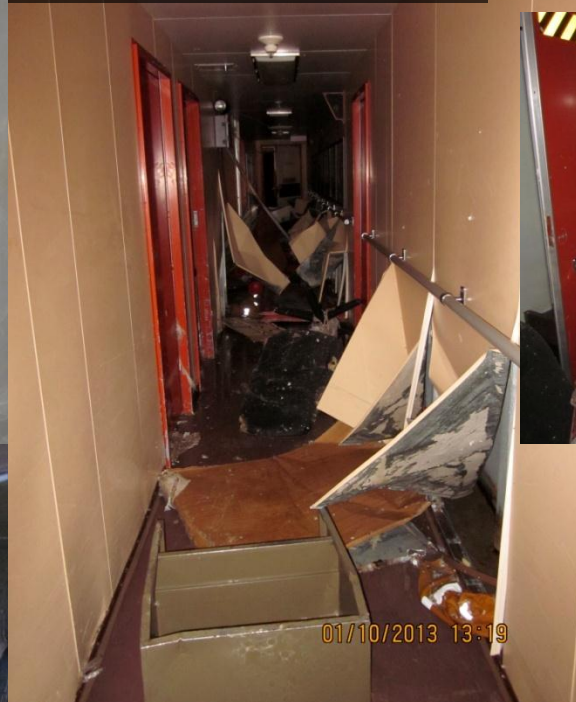
Typical interior damage

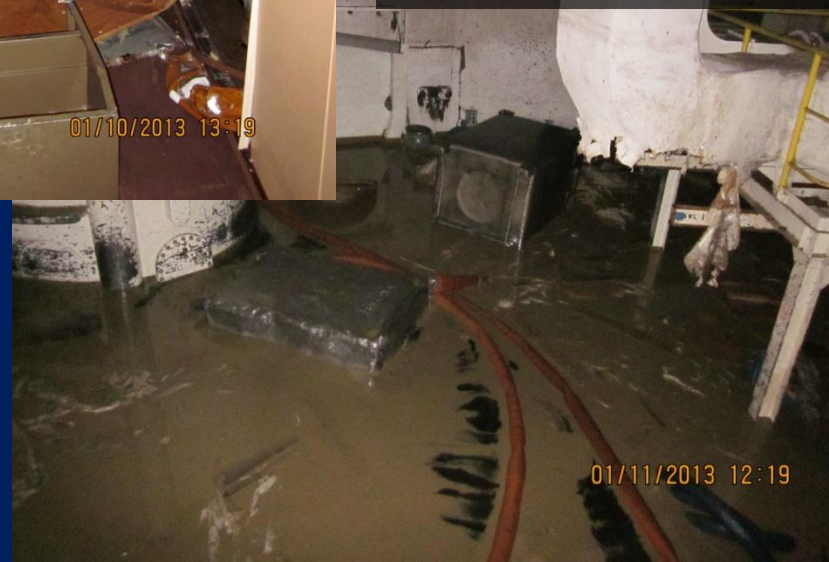
Flooded Compartment
