PLATFORM ANNA

GRANITE POINT FIELD

INSTALLED 1966

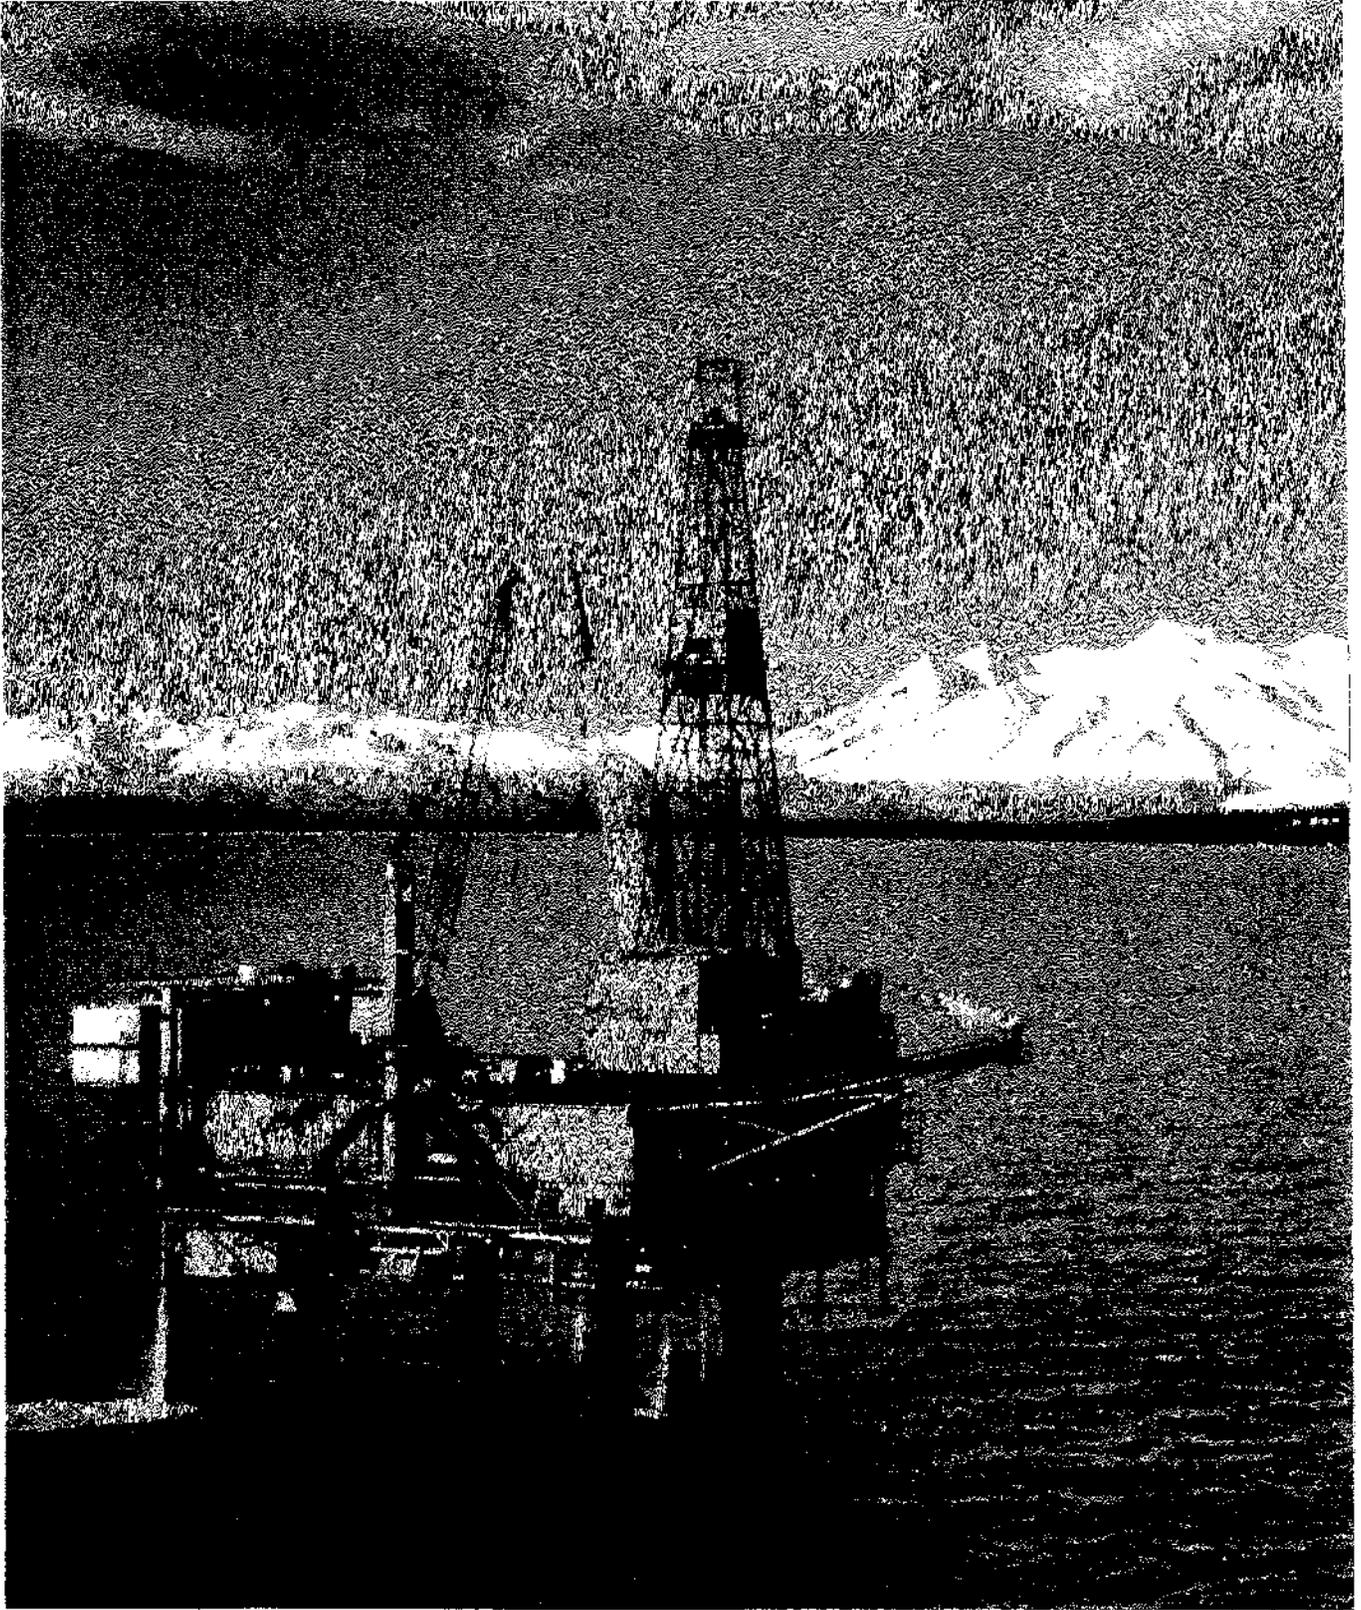
Platform Anna in the Granite Point field.

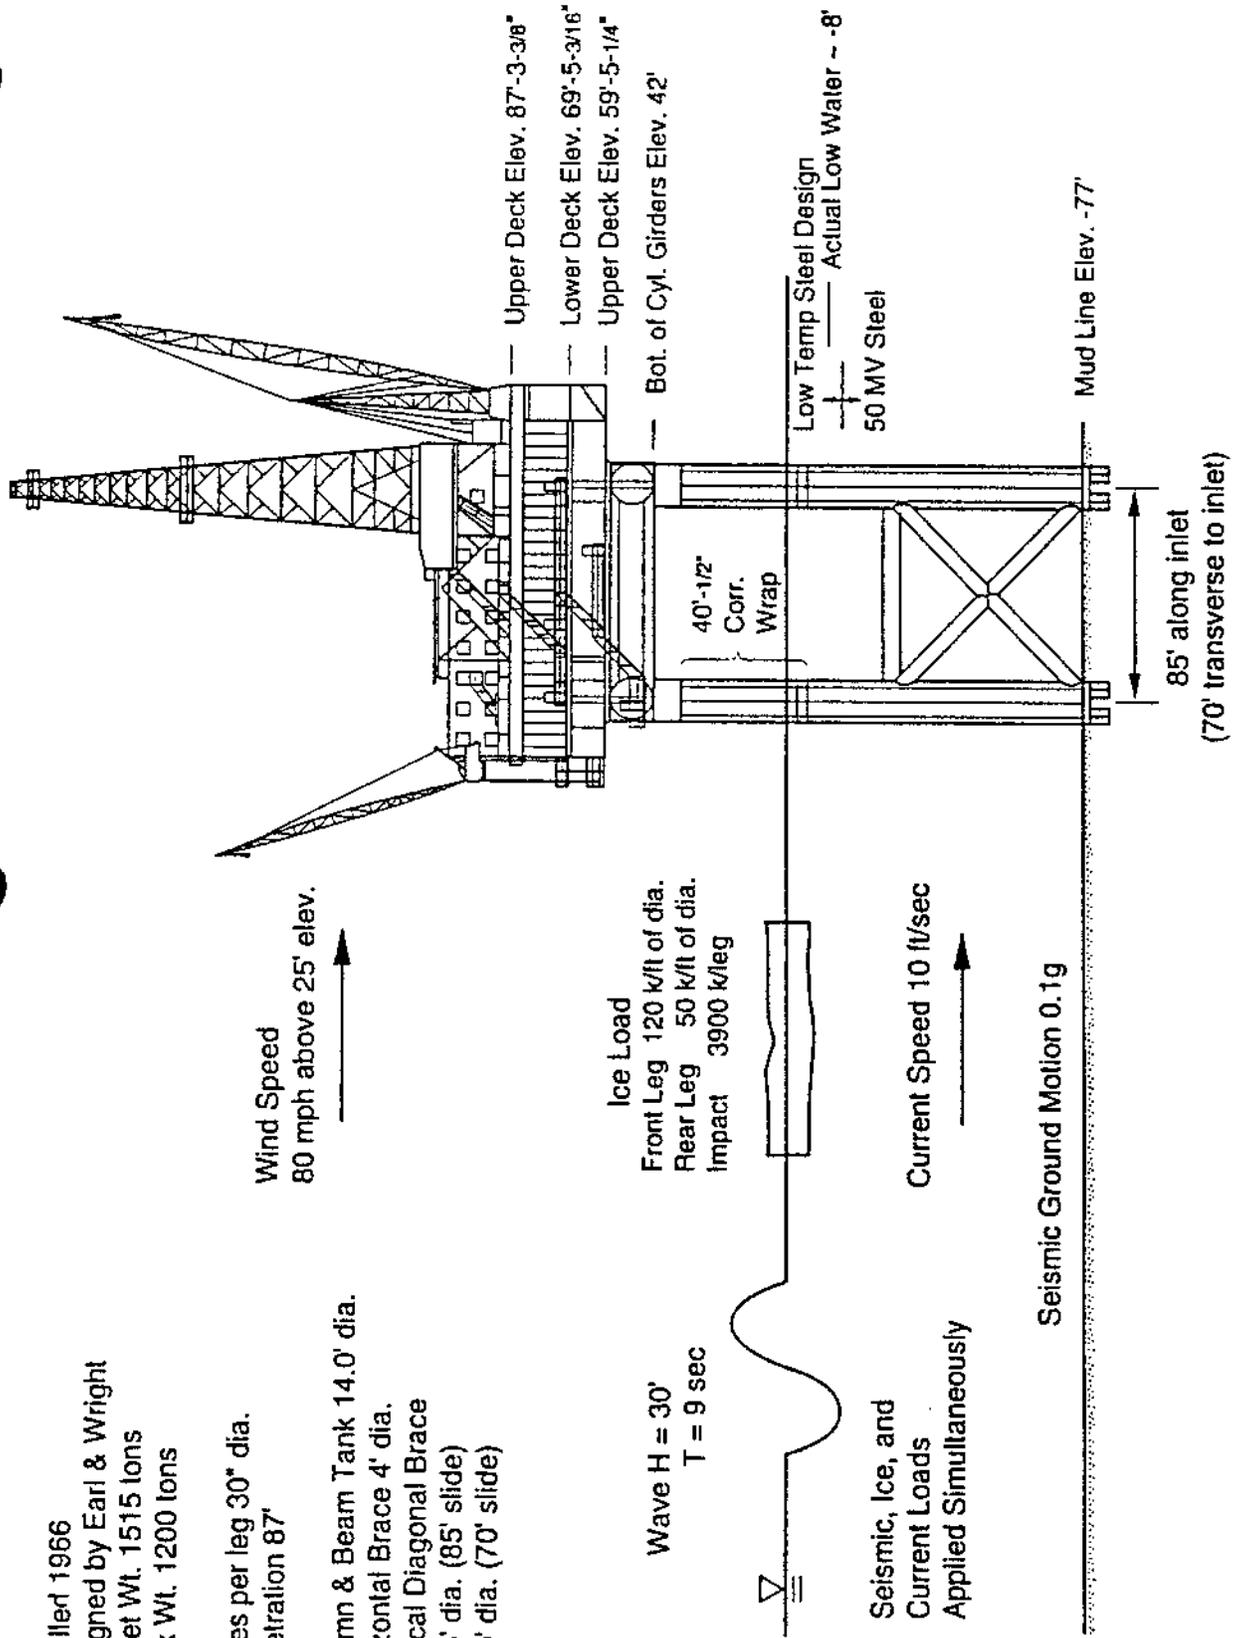
Elevation view and summary details of platform Anna.
