Hilcorp Alaska, LLC

Cook Inlet Offshore Update

MGS A to Shore Pipeline

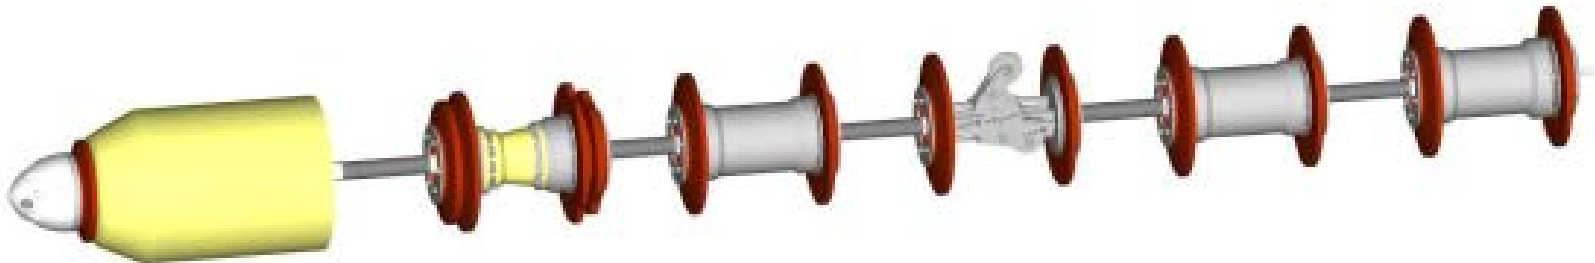
Smart-Pig: UT Piglet

- In-line uni-directional corrosion detection tool.
- Measures metal loss, dents, and GPS location.
