Kulluk Grounding

Captain Paul Mehler III

Commander, United States Coast Guard Sector Anchorage

**REPORT OF INVESTIGATION INTO THE CIRCUMSTANCES SURROUNDING THE
GROUNDING OF THE MOBILE OFFSHORE DRILLING UNIT (MODU) KULLUK ON
THE EASTERN COAST OF SITKALIDAK ISLAND, ALASKA
ON DECEMBER 31, 2012**

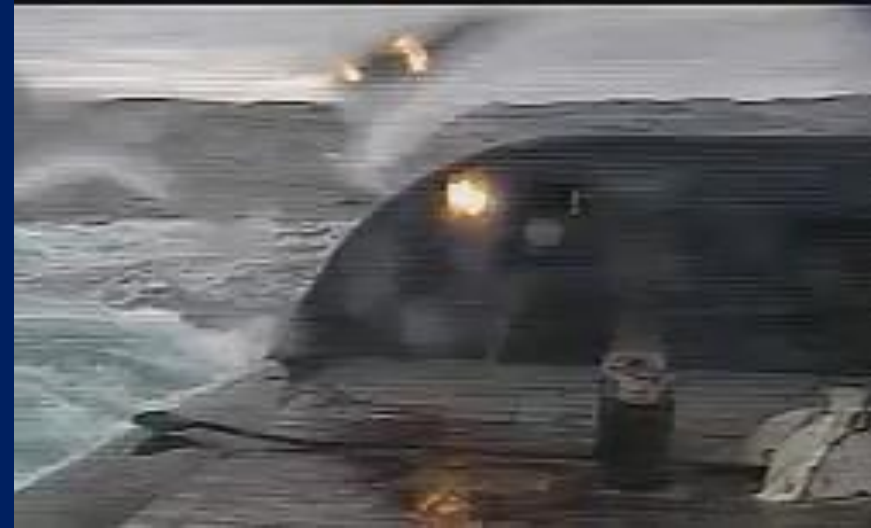
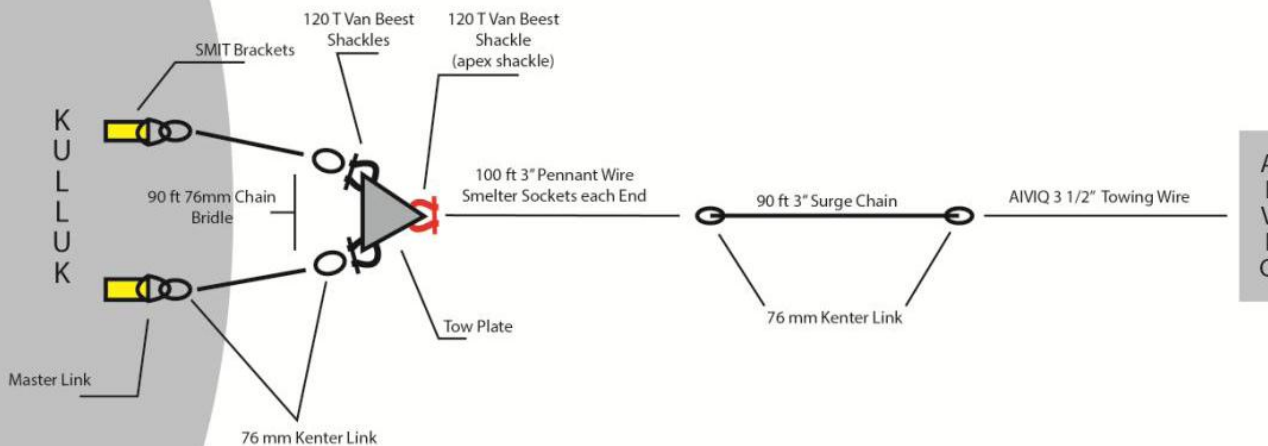
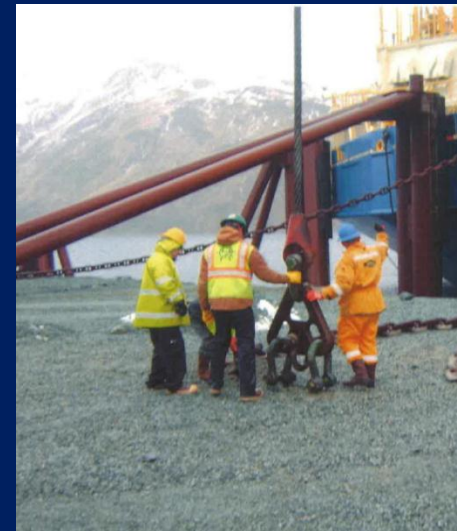
27 December 2012

- Aiviq's tow connection parts
- The Kulluk drifts before an emergency tow line is established
- Guardsman and Nanuq dispatched toward Kulluk
- Aiviq loses all four main engines

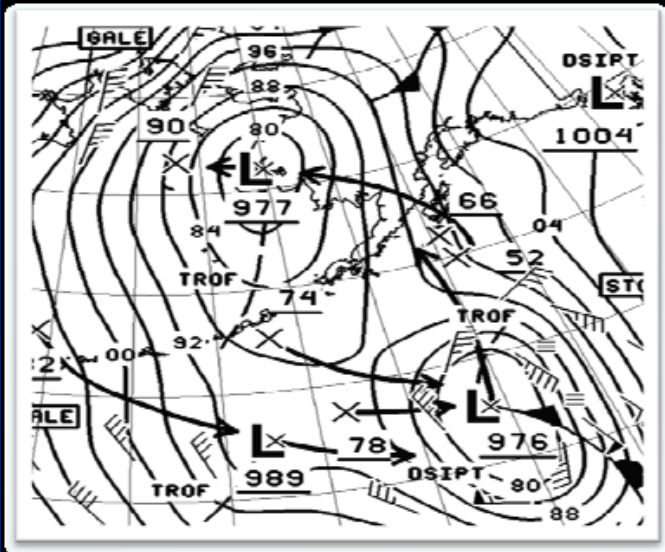
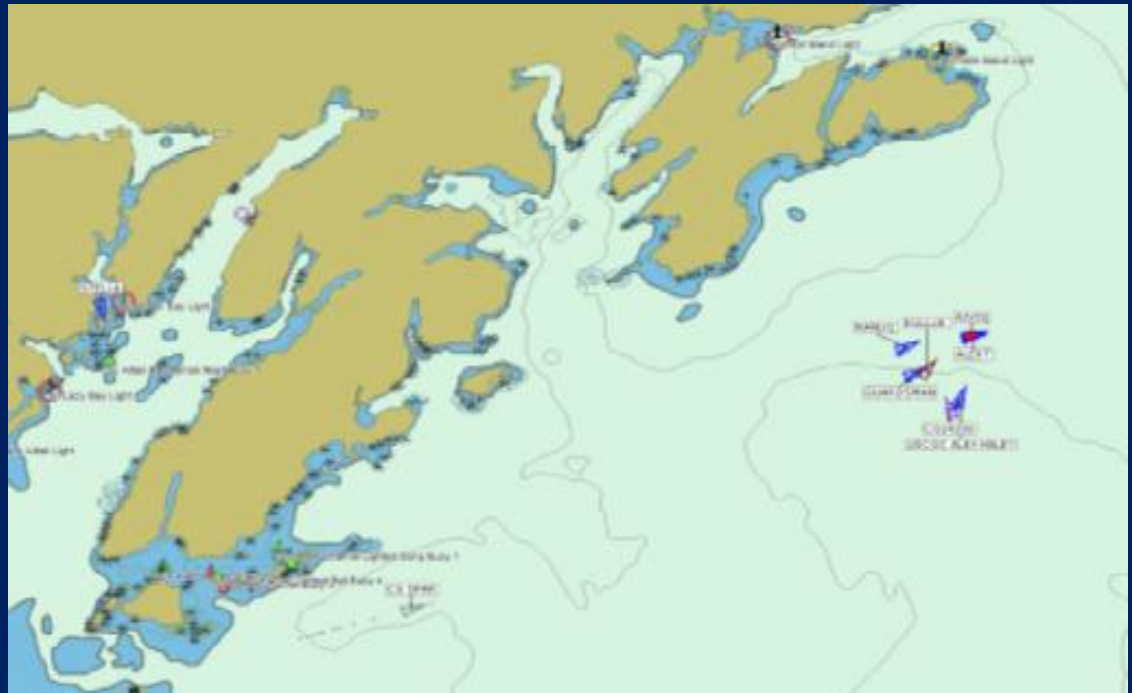
31 December 2012

- D17 Incident Management Team activated to support ICP
- Strong winds and rough seas continue to impact tow efforts
- Aiviq towline parts, leaving Alert alone towing Kulluk
- Alert follows Unified Command direction to release tow line to Kulluk to protect Alert and crew from possible grounding
- Kulluk grounds on the southeast side of Sitkalidak Island, Alaska

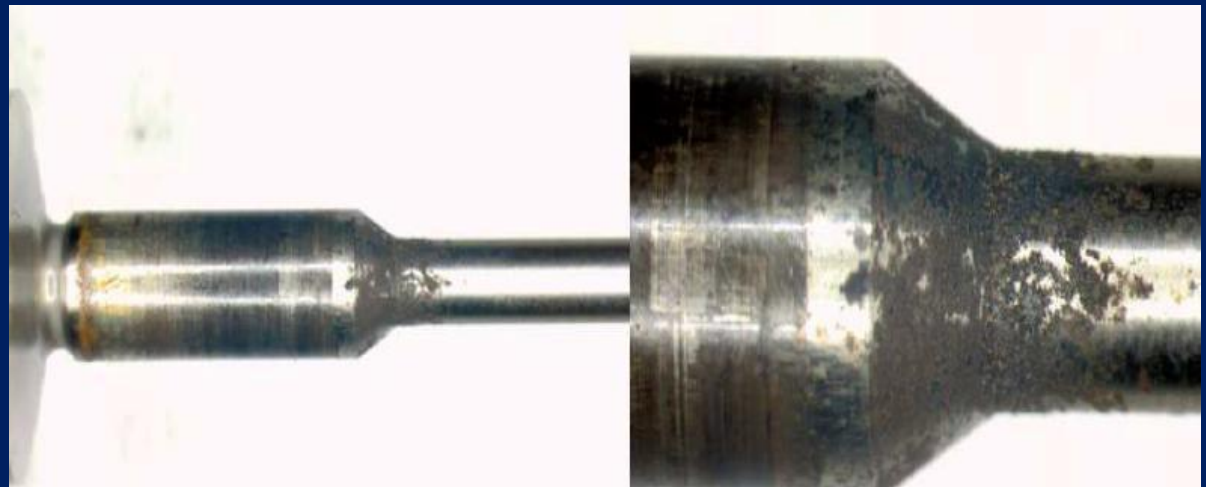
Conclusions – Aiviq Propulsion

- Extensive corrosion was found in main engine and generator fuel injectors after the casualty
- Vessel design problems allowed seawater to enter through vents and contaminate the fuel system in heavy weather
- The crew had altered the approved configuration of the fuel system, inadvertently eliminating protective redundancies
- The company did not provide adequate fuel management policies and procedures
