# Cook Inlet Risk Assessment FINAL REPORT

January 27, 2015

*Prepared by:* Nuka Research and Planning Group, LLC  
and Pearson Consulting, LLC

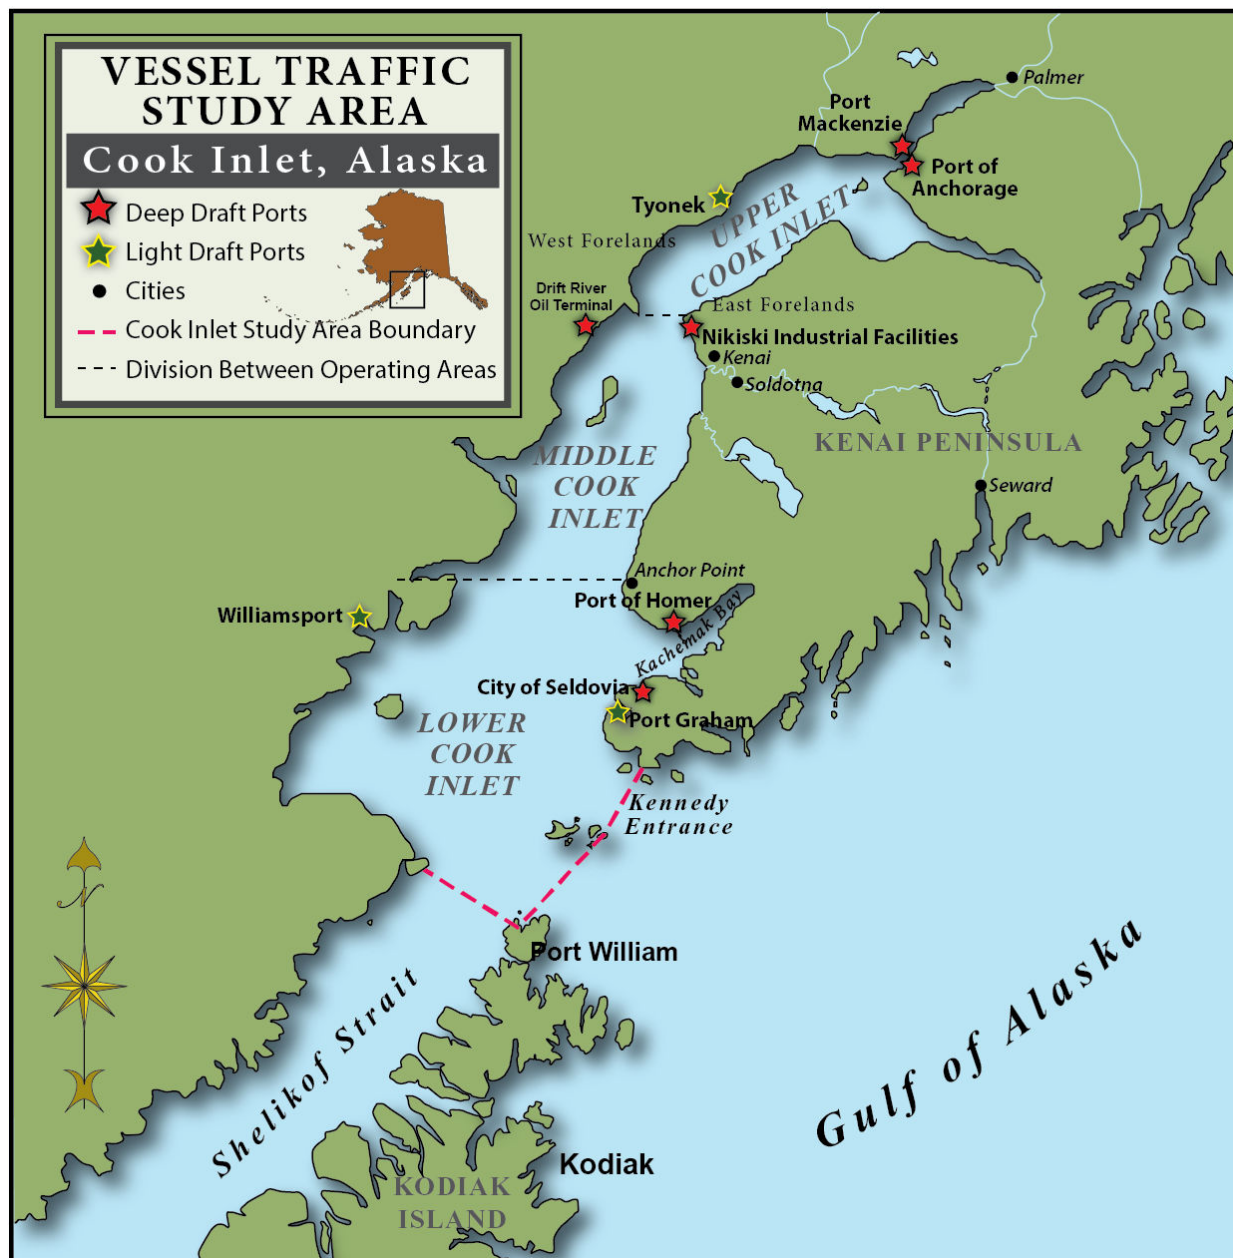
Figure 1. Map of Cook Inlet, including study area boundaries and operating areas

The CIRA focused on the marine waters and coastal areas of Cook Inlet as defined in regulation<sup>2</sup> and shown in Figure 1. Cook Inlet has some of the most extreme tides in the world and is home to commercial and recreational fisheries; petroleum exploration, extraction, and transport; tourism; subsistence use; and both endemic and migratory birds and wildlife. More than 40% of Alaska's population lives in the Cook Inlet region and the vast majority of the state's commodities and goods are shipped through its ports. Conditions and activities vary across the Inlet's operating areas, which are defined as: Lower, Middle, and Upper. These are shown in Figure 1.

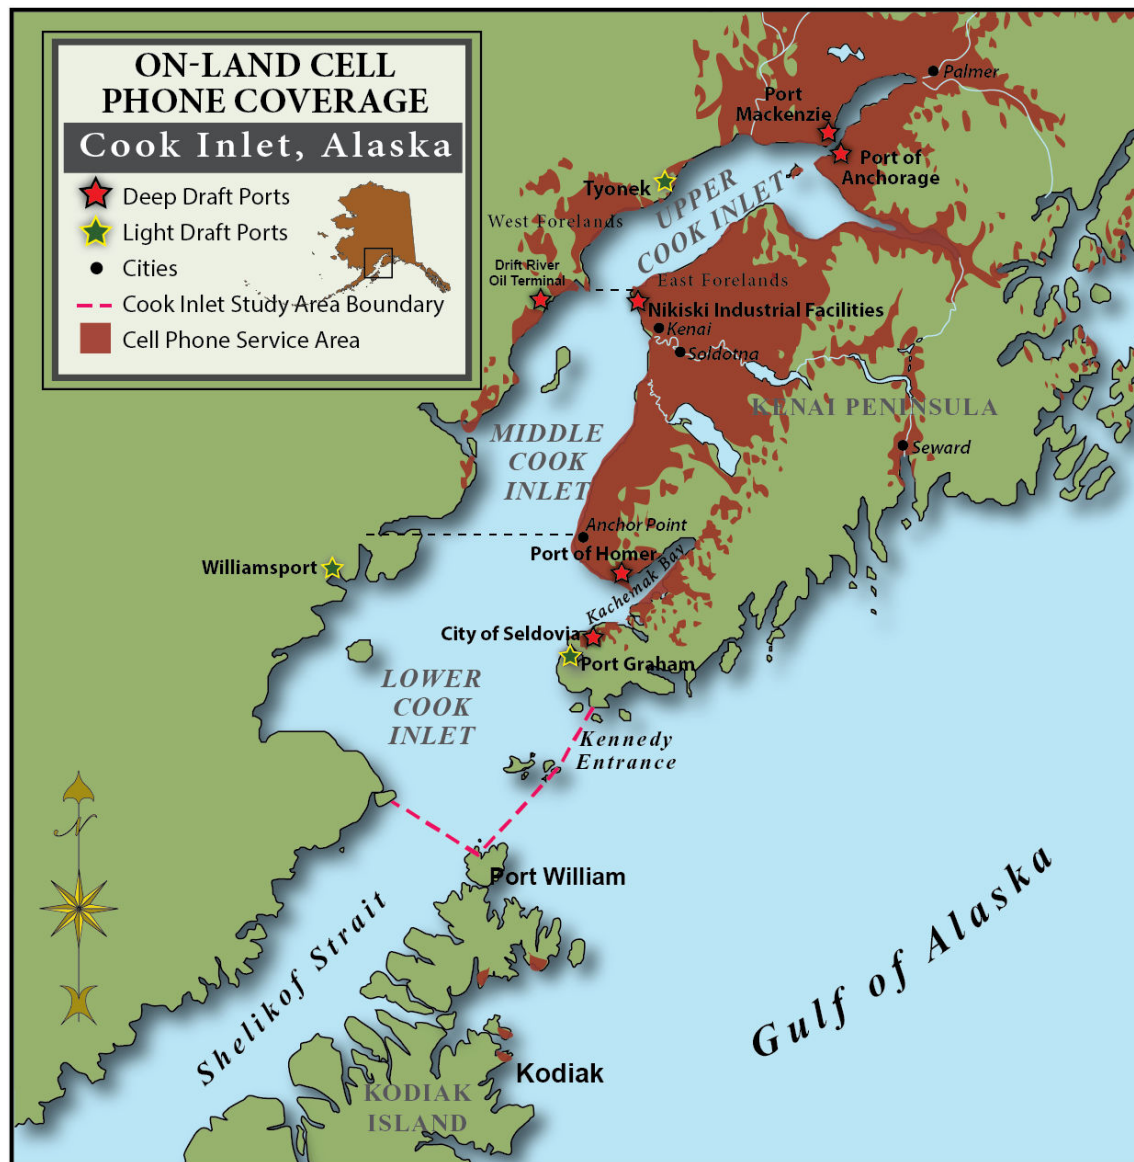
**Figure 6. Generalized on-land cell coverage area, based on Verizon Wireless (Verizon, 2013)**

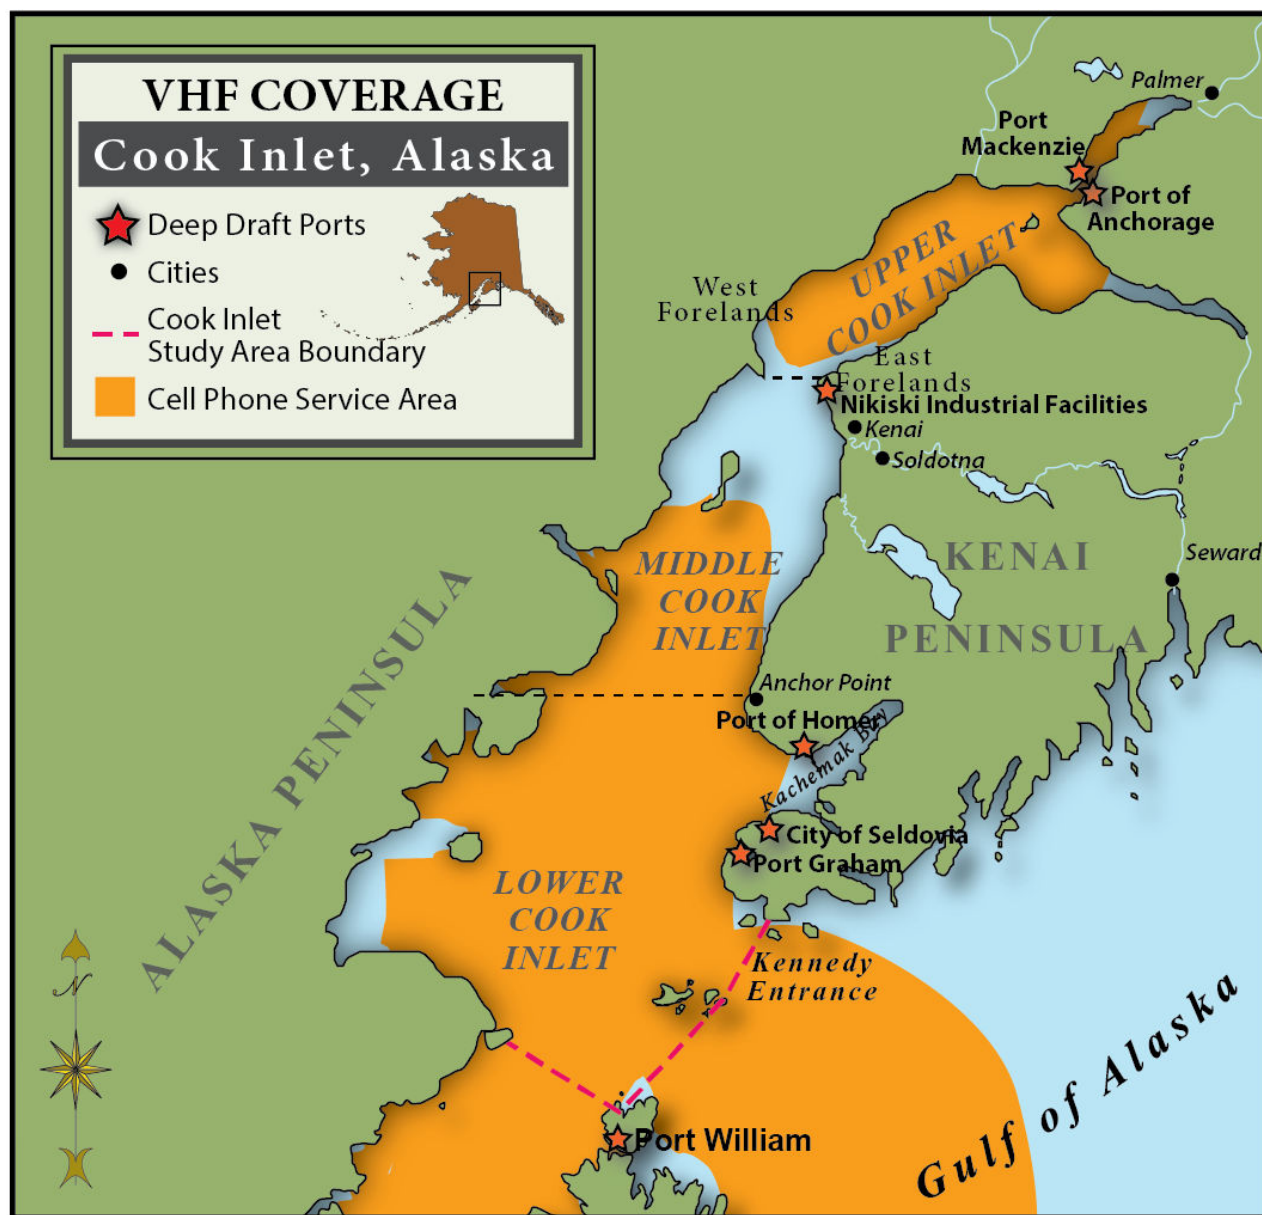
Figure 7. U.S. Coast Guard VHF coverage in Cook Inlet based on a vessel with one watt (based on information provided by USCG Sector Anchorage)

The U.S. Coast Guard maintains VHF stations on shore to facilitate communications between vessels and shore-based resources. Stations serving the Inlet provide coverage for much of the Upper and Lower Cook Inlet areas. However, there is a gap in coverage for vessels operating in the northern part of the Middle Cook Inlet area, up to and just past the Forelands. The gap, portrayed in Figure 7, will vary depending on the size and the power of the vessel's VHF radio.

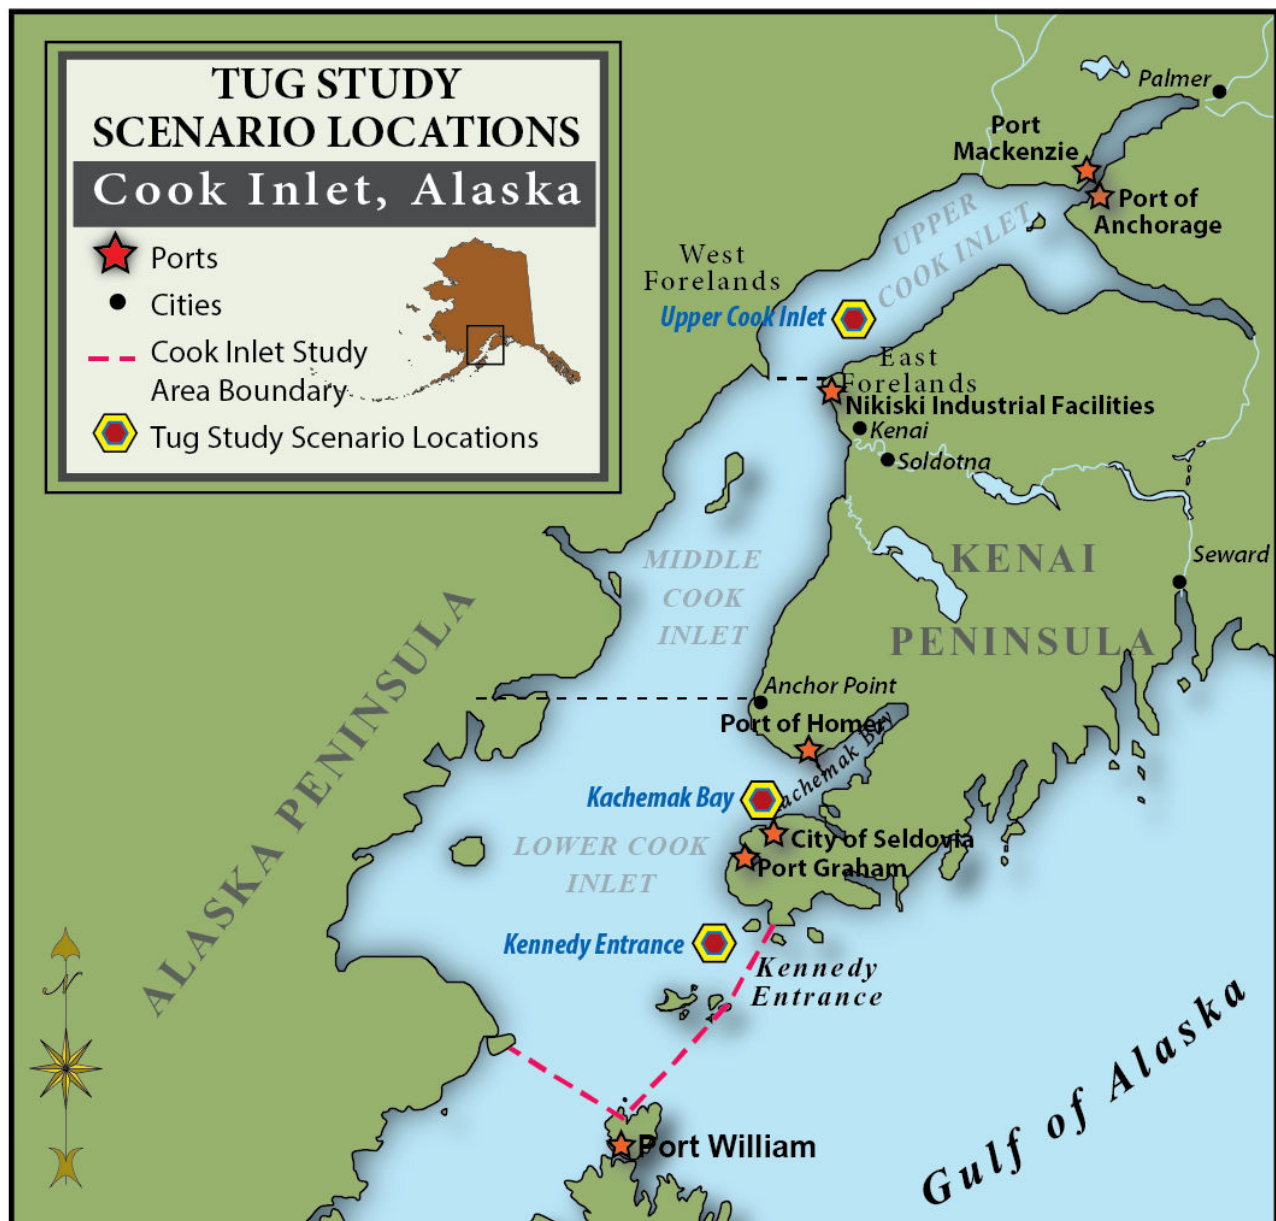
Figure 9. Three scenario locations for Cook Inlet towing analysis

The *Evaluation of 2012 Tugboat Response Times* (The Glosten Associates, 2013b) estimated the minimum bollard pull required to control a disabled vessel, assuming the rescue vessel arrests the drift of the disabled vessel and turns it into the direction of the prevailing drift (gain control and arrest its drift). The estimated minimum bollard pull is derived from the scenario conditions summarized in Table 6 and depicted in Figure 9.

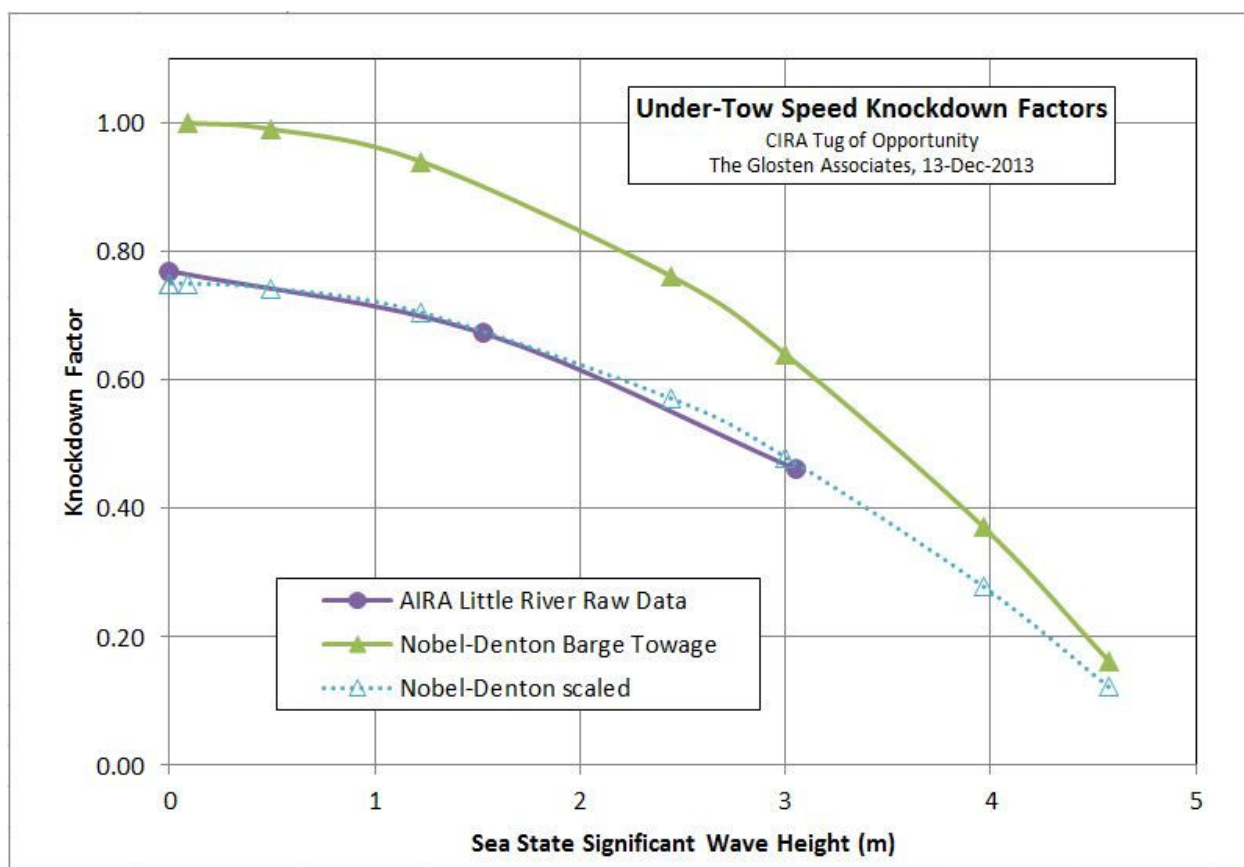
**Figure 3 Comparison of Nobel-Denton and Little River under-tow speed knockdown factors**

Maximum free-running speed is scaled down for higher sea states and for towing a barge. Two sources are used. Nobel-Denton is a general approach to account for sea state and barge towage (Reference 5). This formula is plotted in green in Figure 3. The second source is three data points from Little River consultants, specifically for operating in Alaska (Reference 6). The AIRA Little River speed knockdowns are 75% of the Nobel-Denton towage speed knockdowns, in the relevant speed range for this analysis. These points are plotted in purple. This source governs, because it is more conservative and more specific to this project's application. The Nobel-Denton formula was scaled down to align with the Little River Data, and this formula was used to calculate the speed knockdown factor by significant wave height.

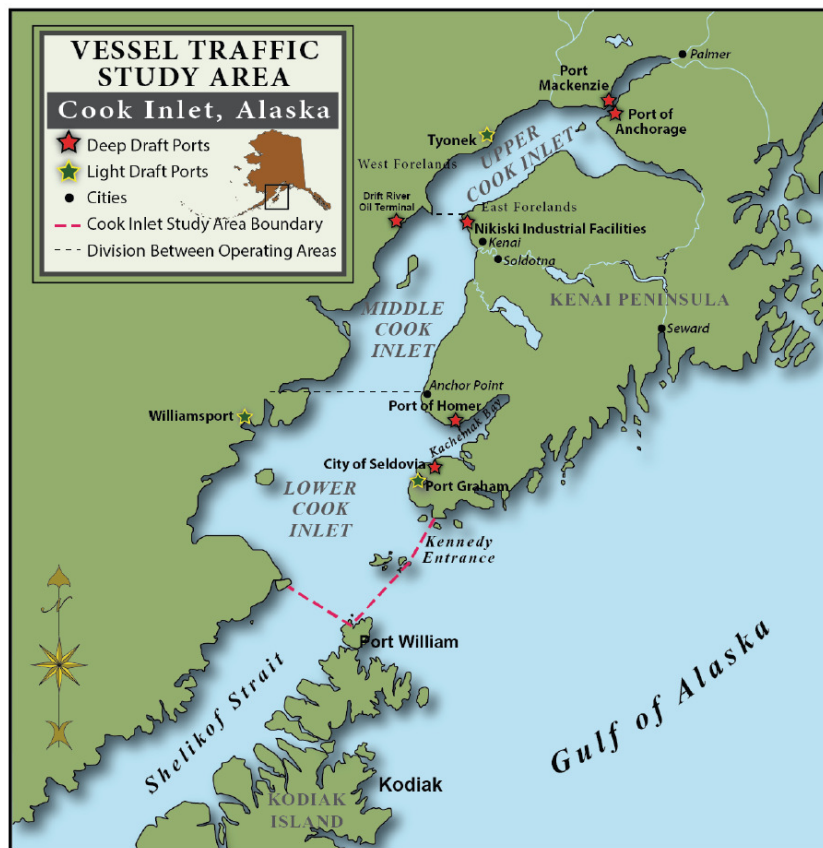
**Figure 1.2: Map of Cook Inlet Areas**

Figure 1.2 includes a map showing the Cook Inlet Areas.
