PLATFORM A

MIDDLE GROUND SHOAL FIELD

INSTALLED 1964

MGS Platform A

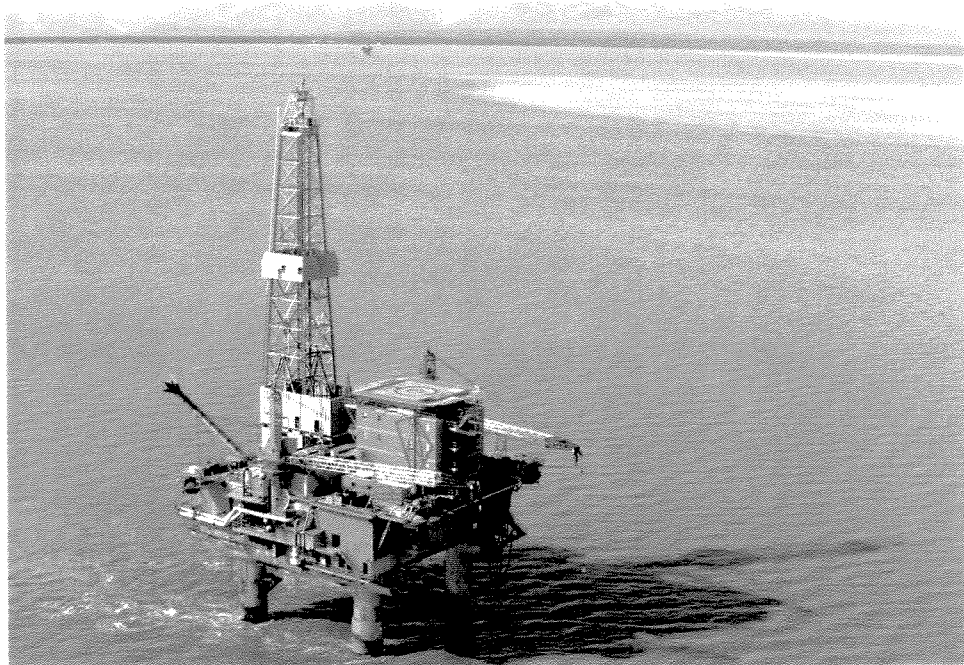
MGS Platform "A" with new quarters and drilling rig.

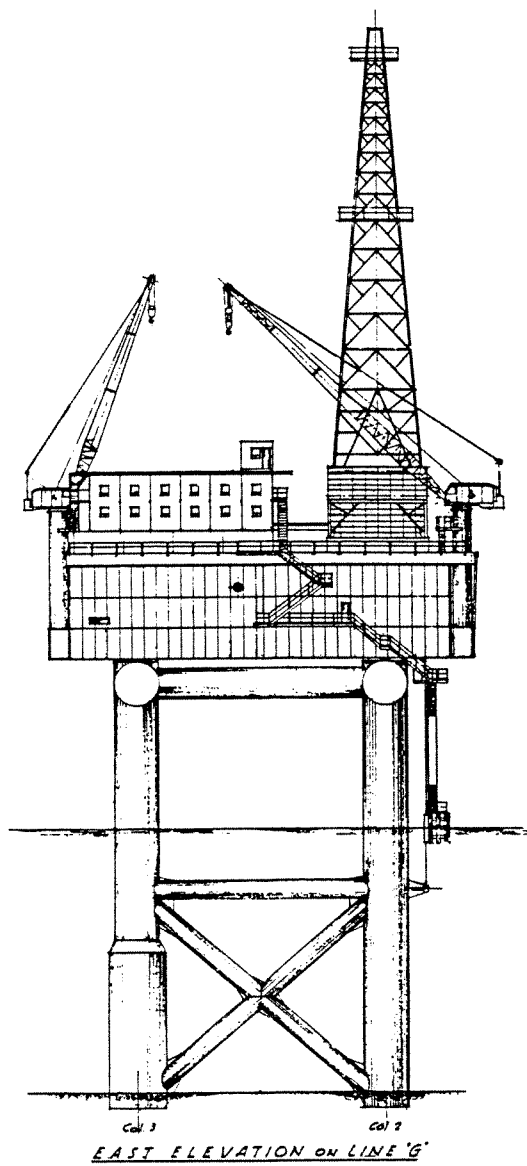
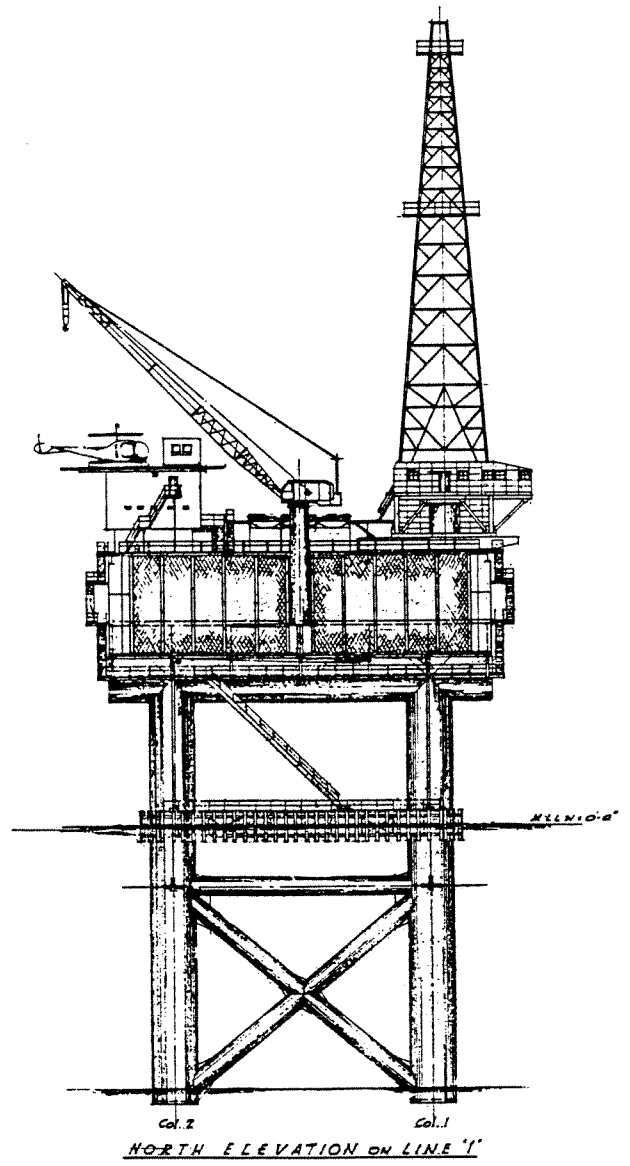
Elevations of MGS Platform A with original quarters and drilling rig.
 Note the adjustable boat landing which was removed during
 the first year of operation.
