PLATFORM DILLON

MIDDLE GROUND SHOAL FIELD

INSTALLED 1966

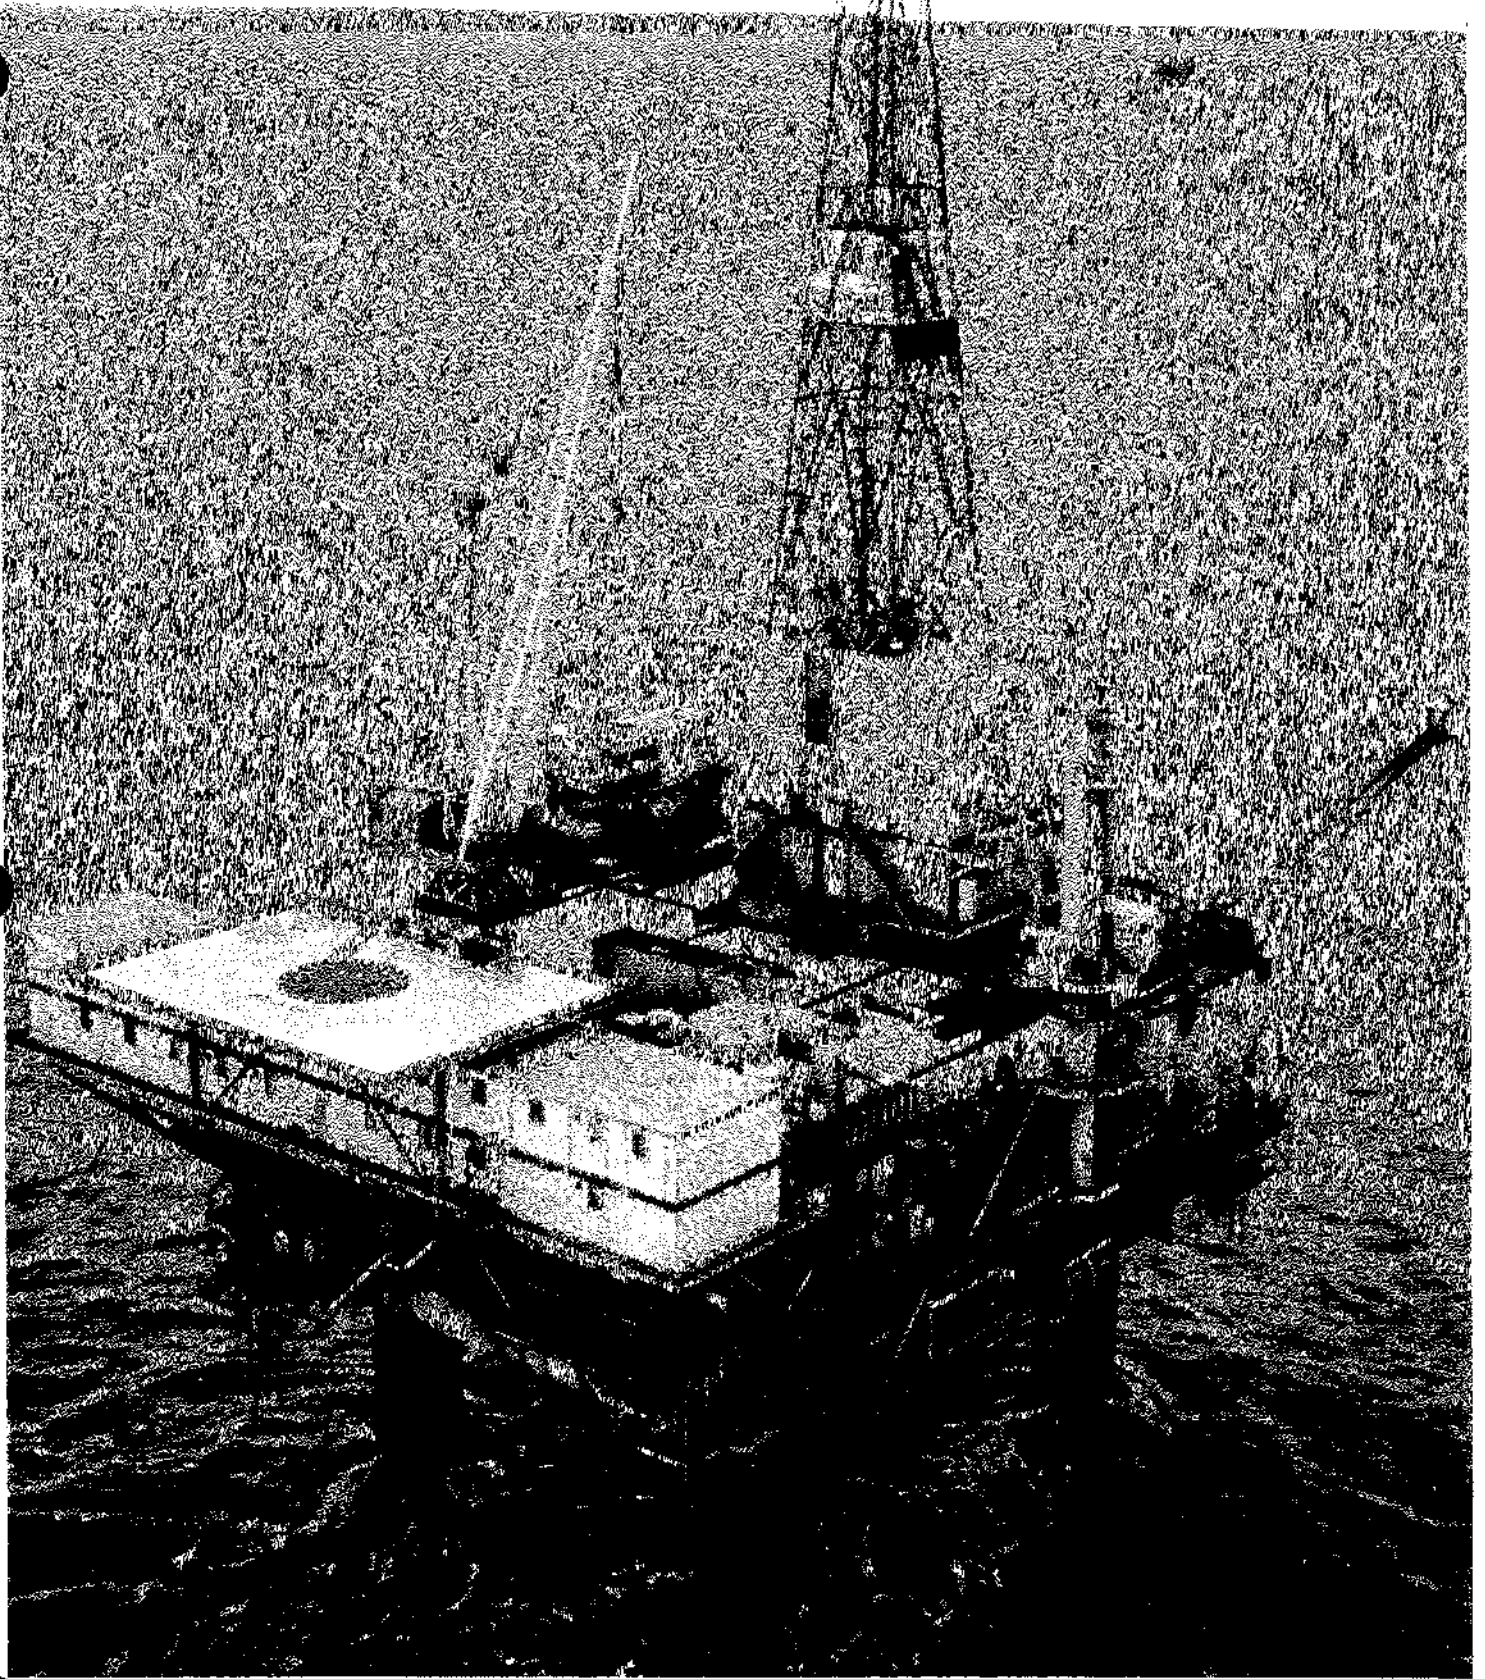
Platform Dillon in the Middle Ground Shoal field.

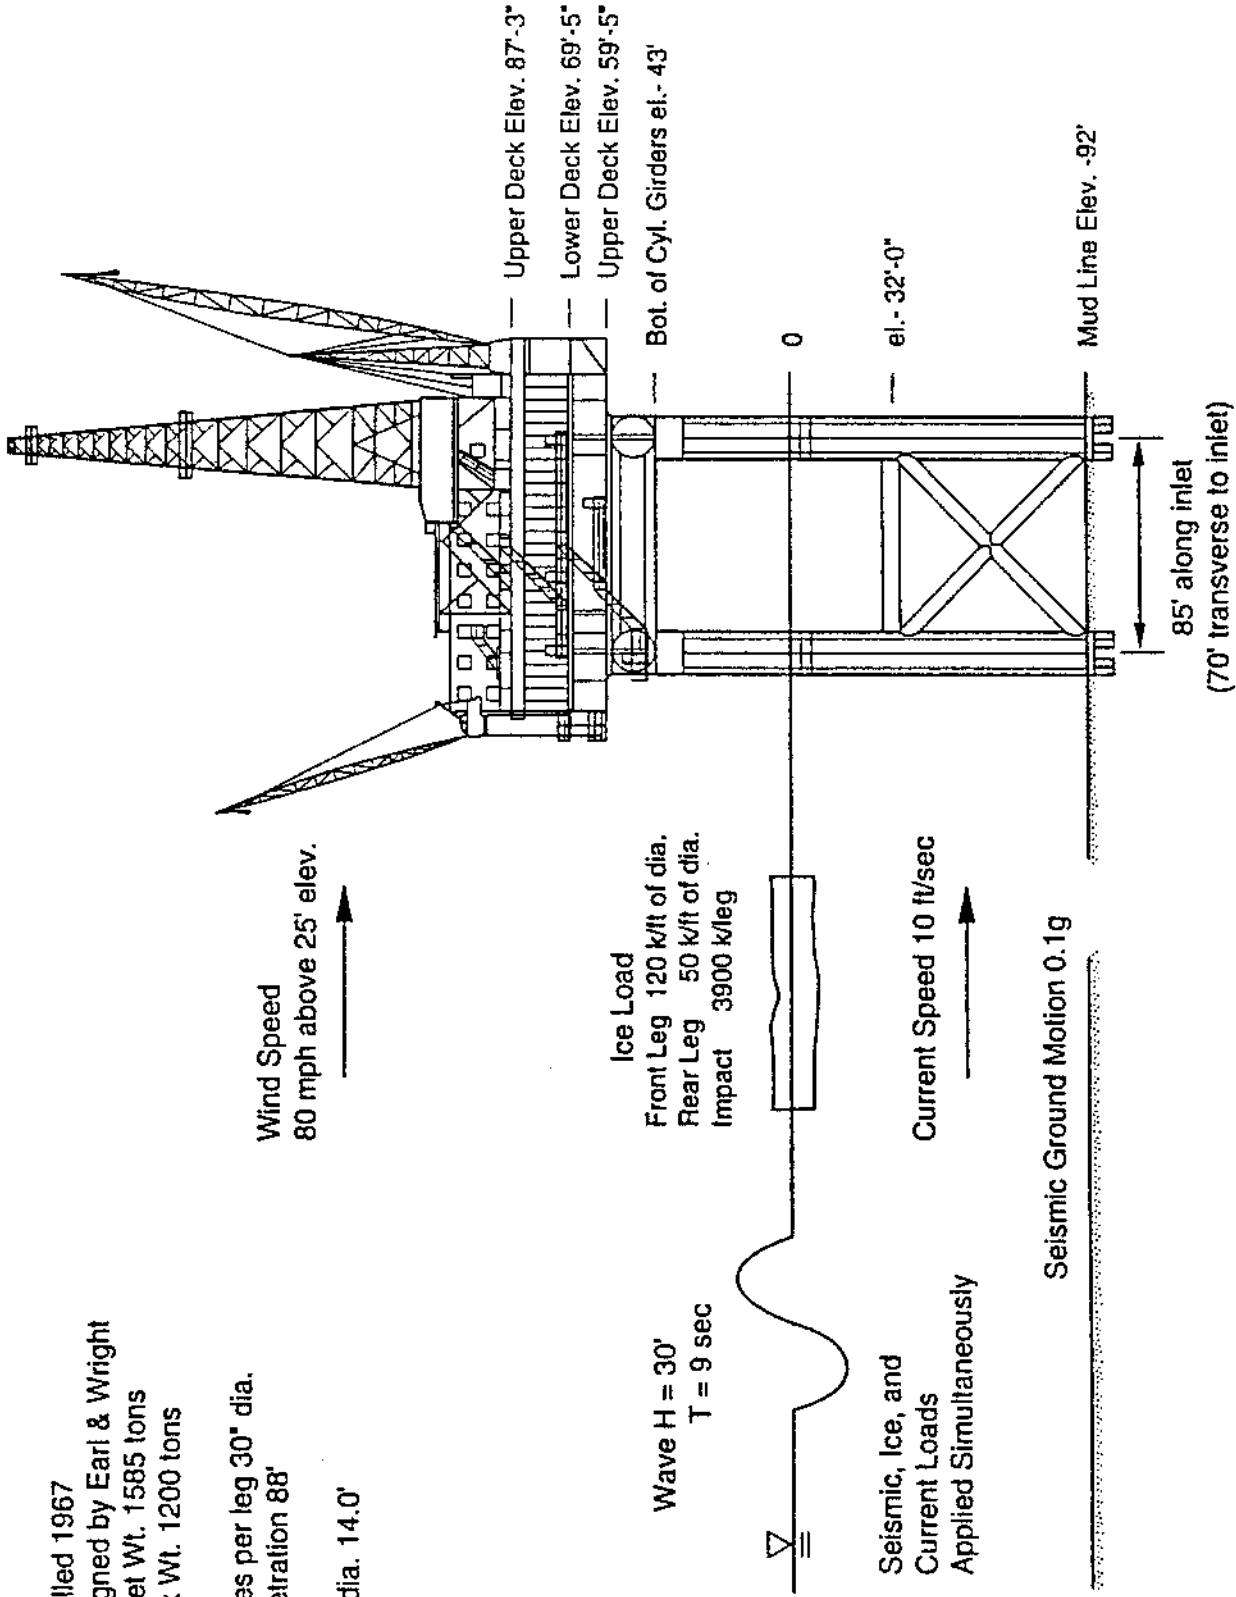
Installed 1967
 Designed by Earl & Wright
 Jacket Wt. 1585 tons
 Deck Wt. 1200 tons

8 Piles per leg 30" dia.
 Penetration 88'

Leg dia. 14.0'

Wind Speed
 80 mph above 25' elev.

Ice Load
 Front Leg 120 k/ft of dia.
 Rear Leg 50 k/ft of dia.
 Impact 3900 k/leg

Wave H = 30'
 T = 9 sec

Seismic, Ice, and
 Current Loads
 Applied Simultaneously

Current Speed 10 ft/sec

Seismic Ground Motion 0.1g

Elevation view and summary details of platform Dillon.

9. *Number and diameter of legs:*.....Four legs; 14 feet diameter
 10. *Number, size and penetration of piling:*.....Eight piles per leg; 30 inch diameter; 88 feet penetration.

19. *Design criteria used:*
 - (1) *Ice thickness and strength:*.....Front legs 120 kips/ft of diameter, back legs 50 kips/ft
 - (2) *Wave height and period:*.....30 feet with 9 second period
